Emergency Inspection & Evaluation Summary

Templeton T-02-045 (69L)
Stone Bridge Road over Stone Bridge Pond
September 13, 2018

Town of Templeton

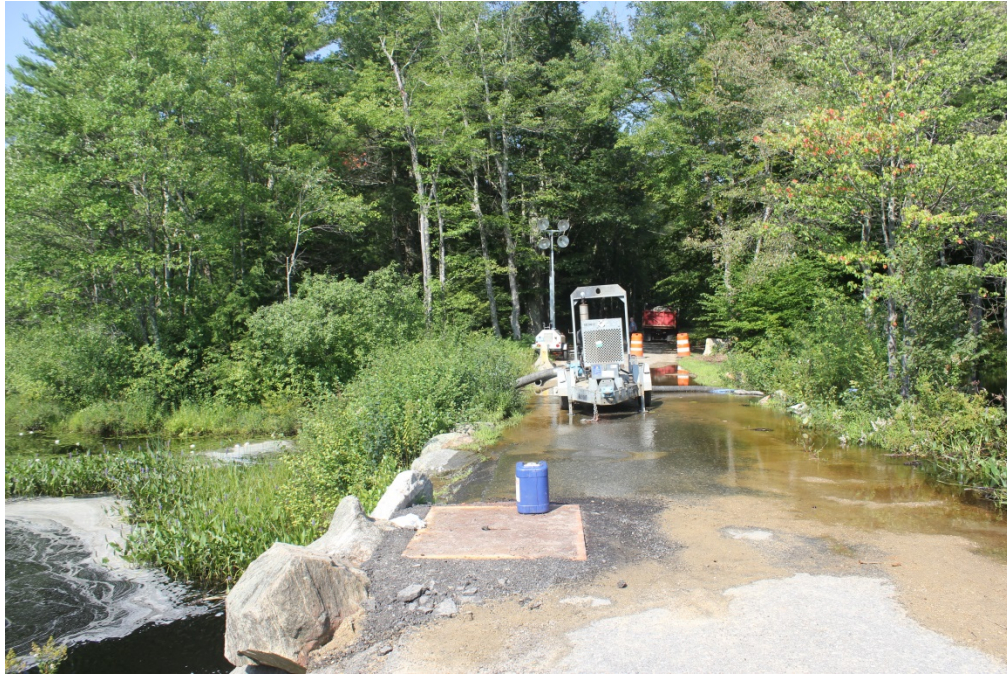
Photo 1 - S. Headwall & Stone Guard Condition East Approach

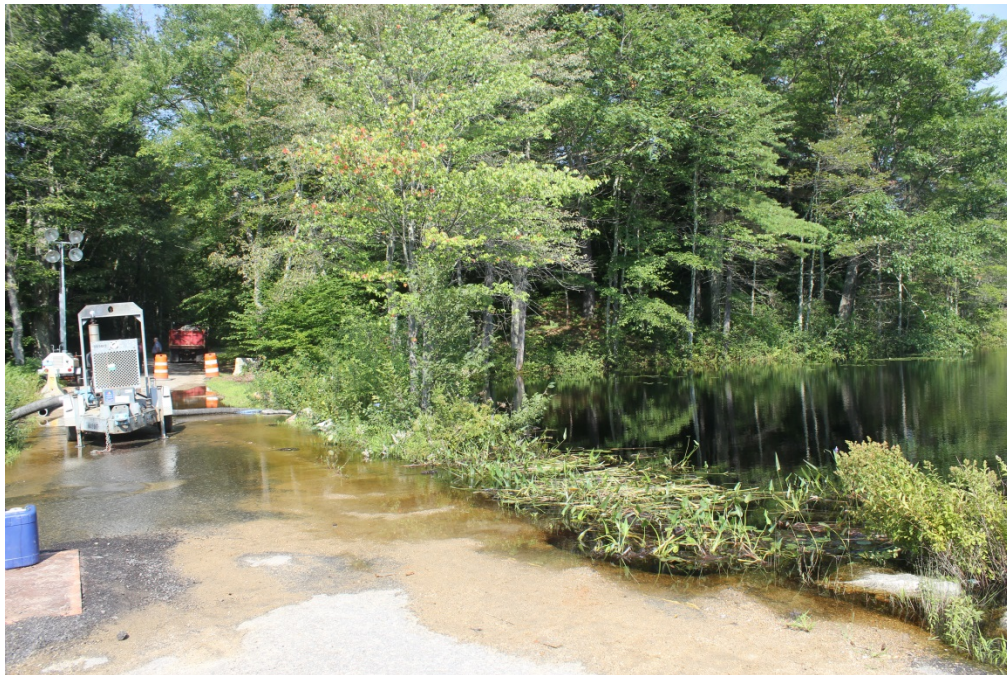
On the northerly (upstream) end of the structure, the edging boulders and edge of the HMA pavement were missing, presumably having collapsed into the waterway.

Photo 2 - N. Headwall & Stone Guard Condition East Approach

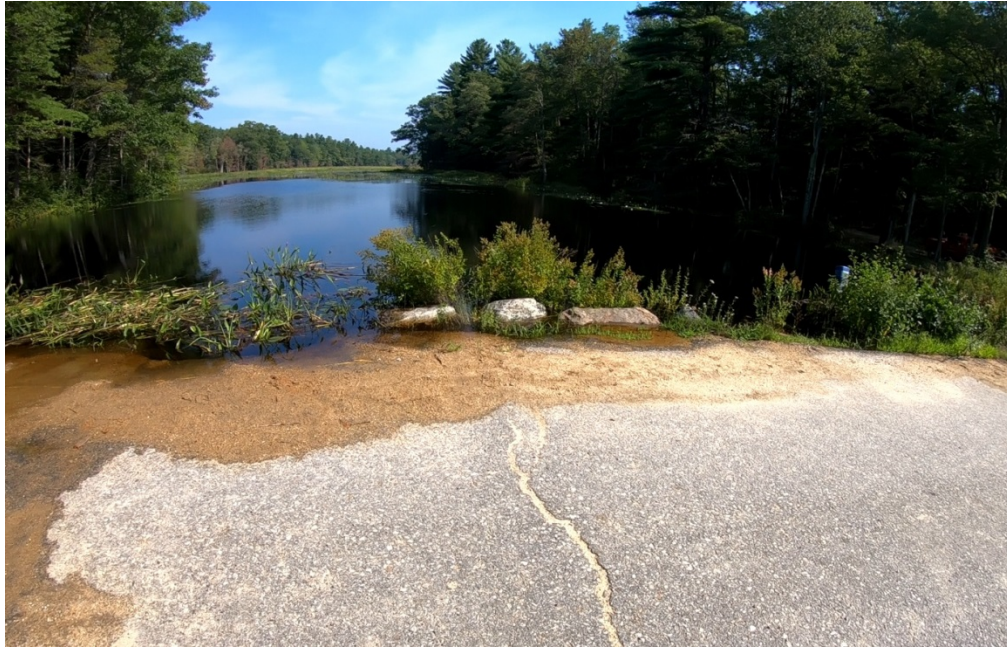
Photo 3 – Upstream Conditions (Looking North)

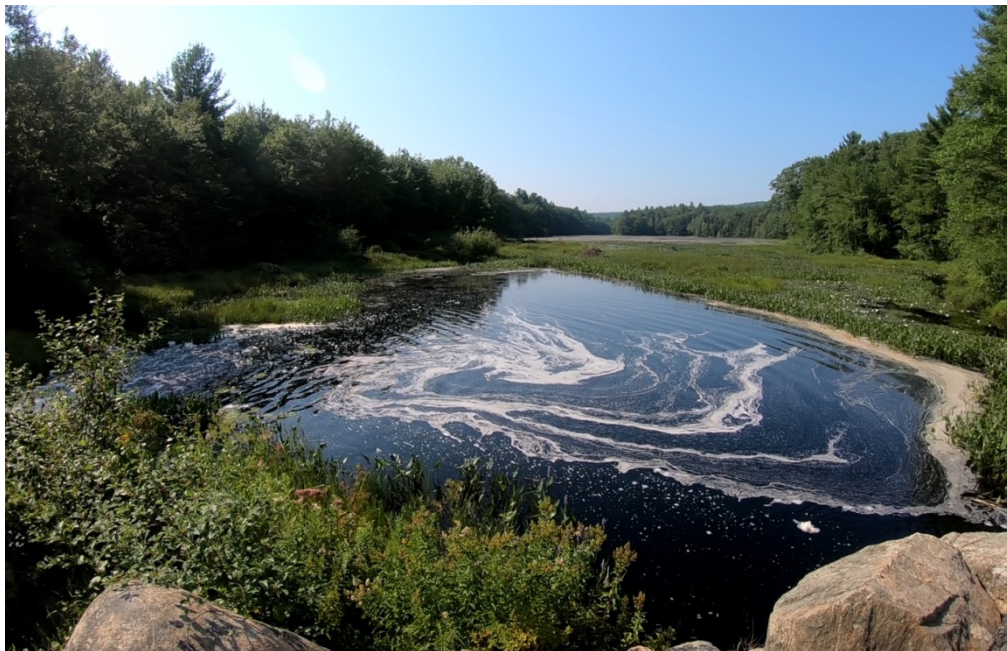
Photo 4 – Downstream Conditions (Looking South)

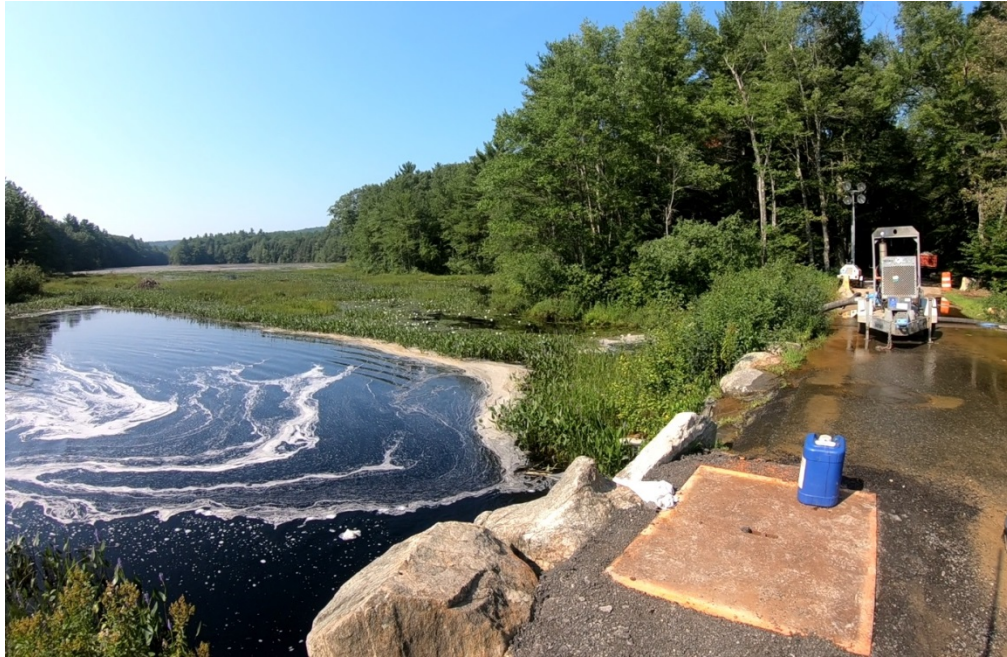
A steel roadway plate was in place with HMA patch securing the plate at the southeast corner of the deck where a prior collapse had occurred.

Photo 5 – Roadway Plate & Stream Overtopping Roadway

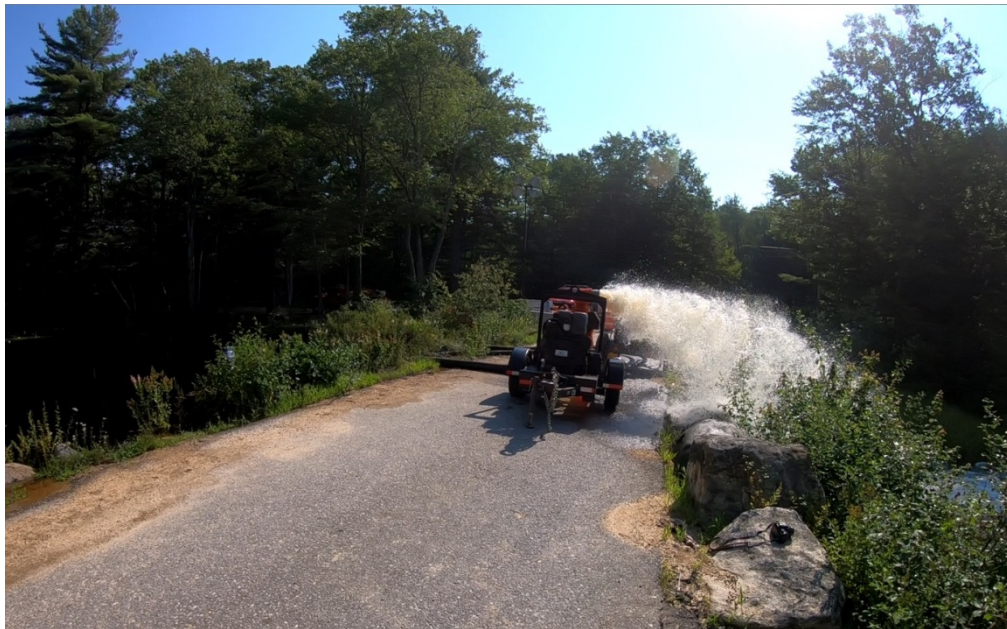
The two six inch (6") portable pumps were actively pumping and it was reported that, after twelve (12) hours of continuous operation, they had managed to slightly reduce the level of the headwater. However there continued to be some flow over the top of the roadway.

Photo 6 – One of Two 6" Diameter Pumps Discharging Downstream

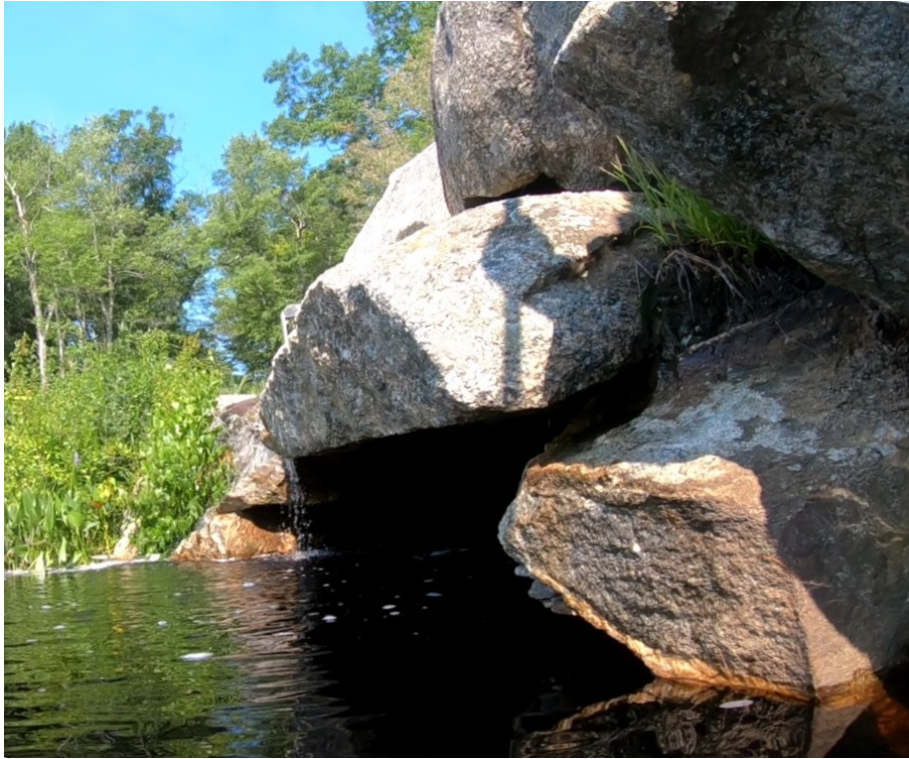
Photo 7 – South (Downstream) End of Structure and Headwall Stone

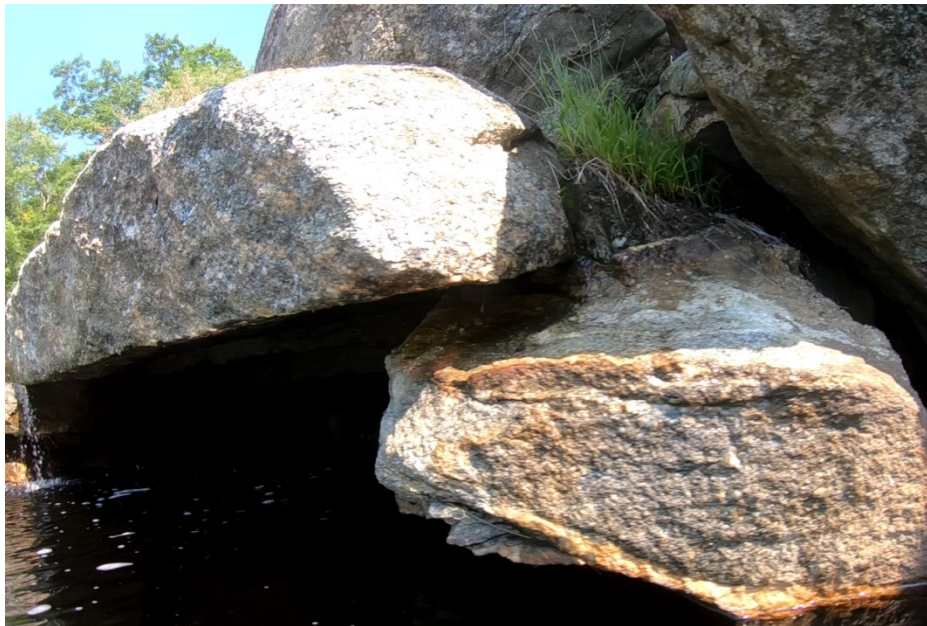
Photo 8 - South (Downstream) Headwall Stone and Support

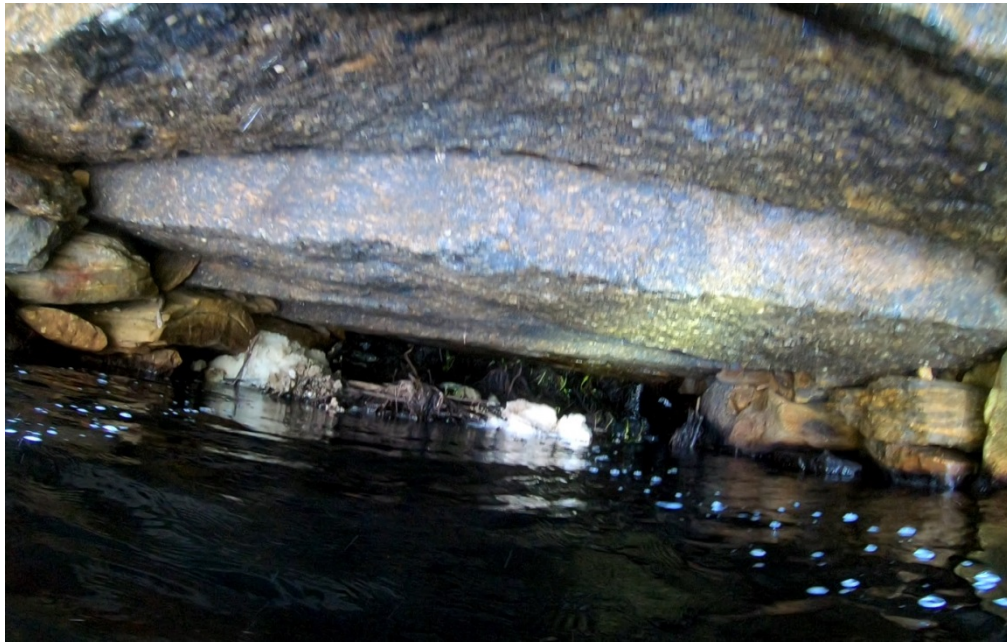
Photo 9 – Roof (Deck) Stones, Stone Abutments & Vegetation at Upstream (North) Opening

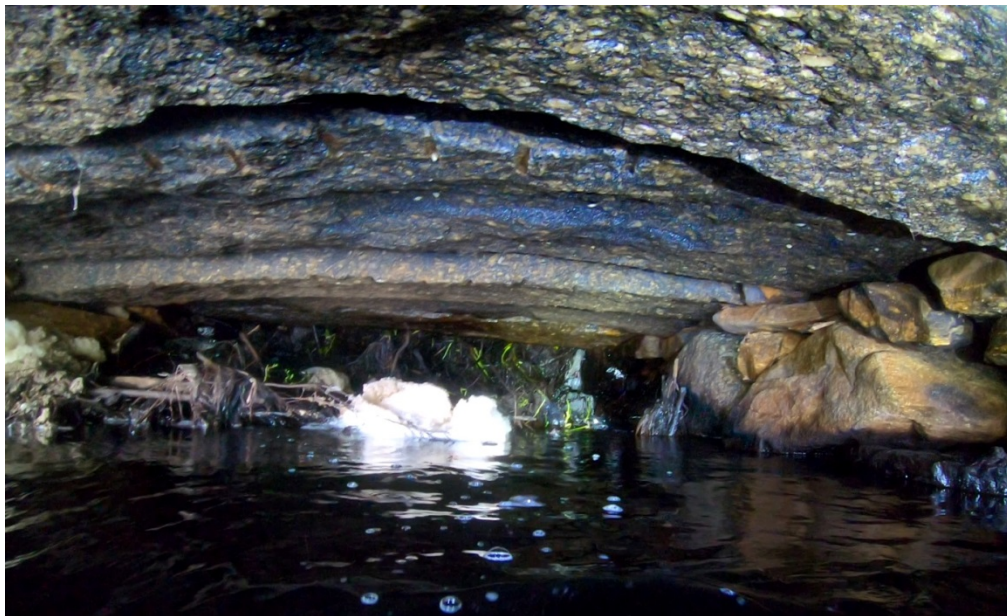
A waterproof video camera secured to a wand was used to view the condition of the structure opening at the southerly (downstream) end of the structure. The images confirmed there was approximately eighteen inches (18") of freeboard between the surface of the water and bottom of the culvert roof (bridge deck) through the length of the structure and that the blockage was actually located at the entrance on the upstream end of the structure. The images from the downstream end showed that only a small amount of flow was entering through what appeared to be a large amount of vegetation and branches.

Photo 10 - Roof (Deck) Stones, East Abutment & Vegetation Blocking Upstream (North) Opening

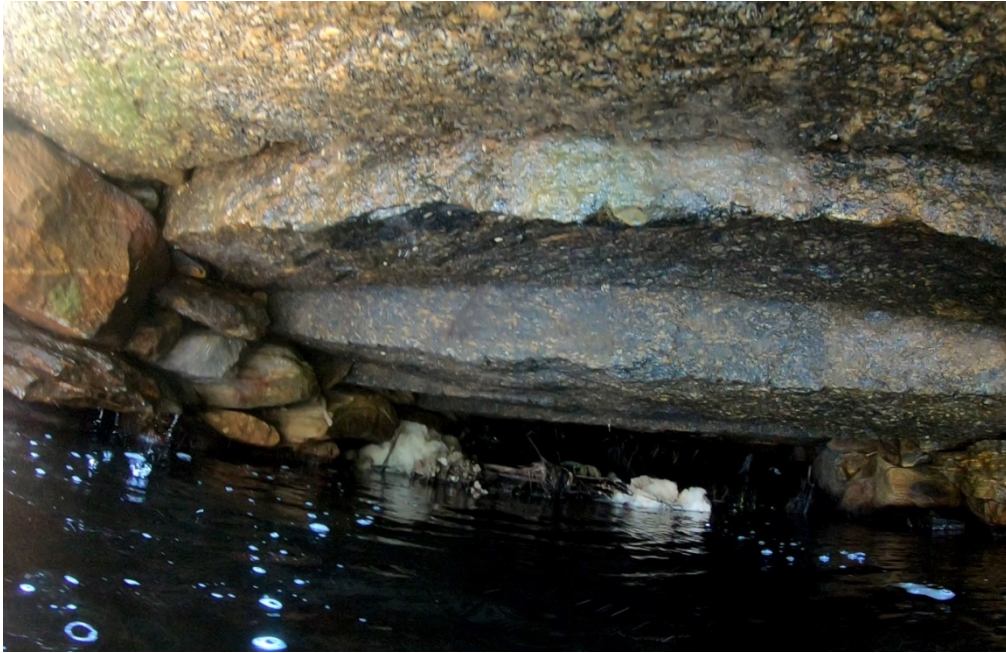
Photo 11 – Irregular Roof (Deck) Stones & West Abutment

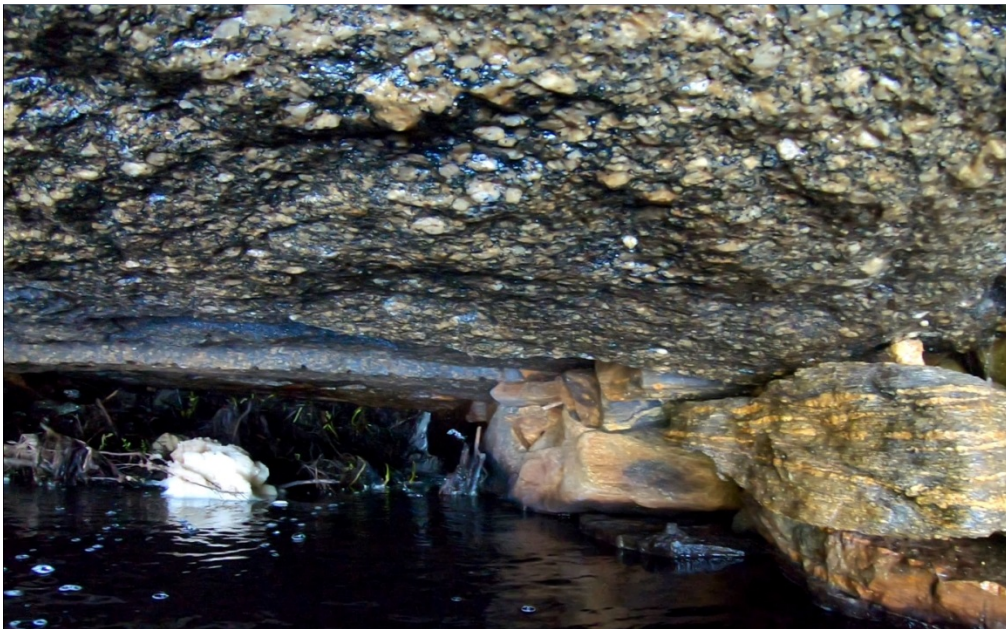
Photo 12 – Roof (Deck) Stones and East Abutment

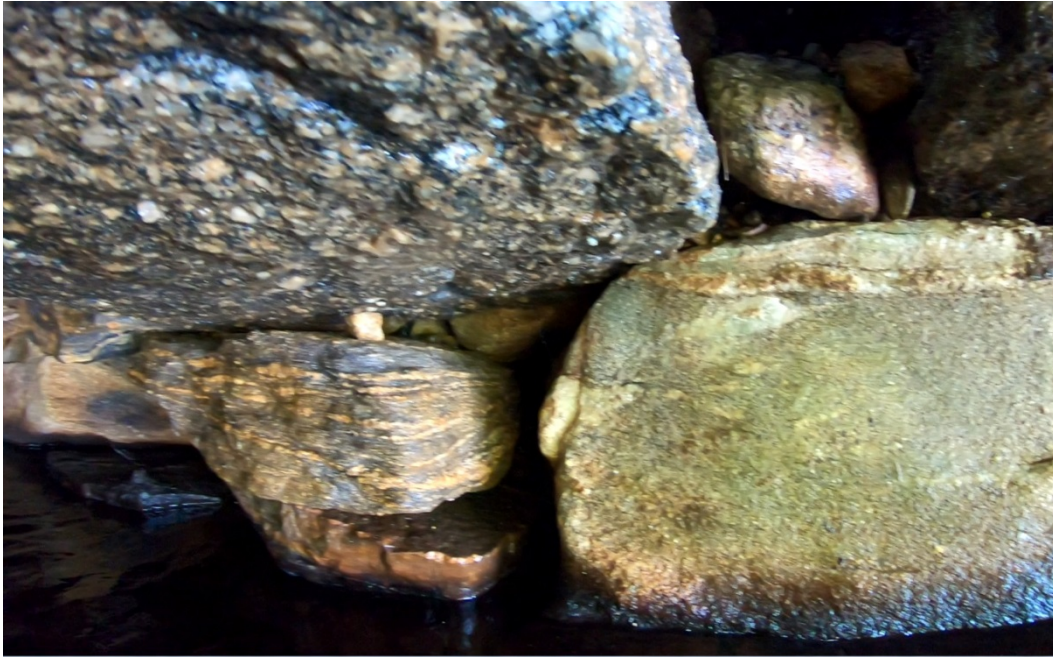
Photo 13 - East Abutment below Roadway Plate

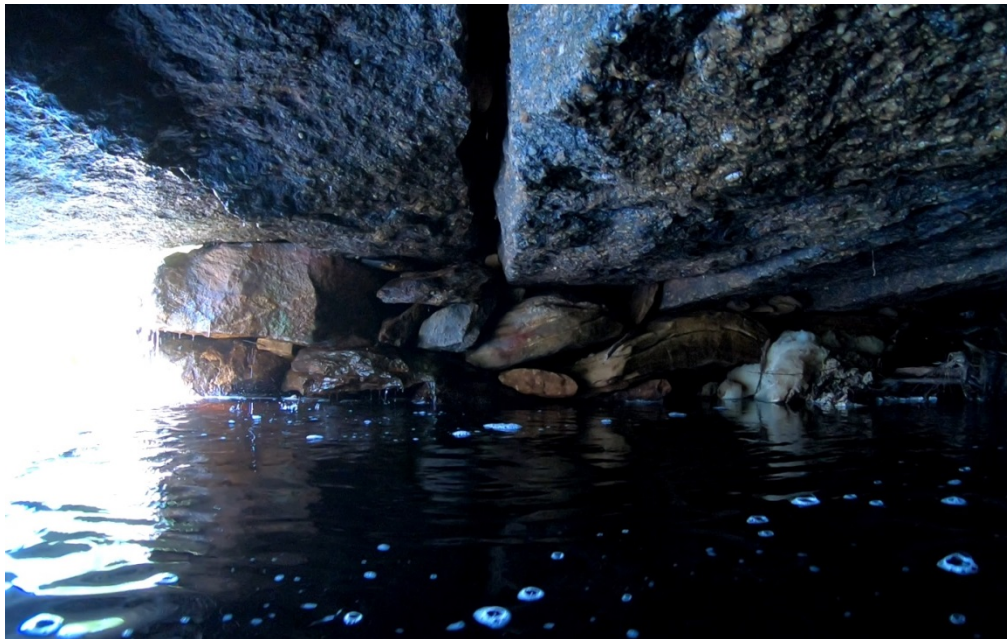
Photo 14 - Roof (Deck) Stones below Roadway Plate and West Abutment
