August 29, 2018

RE: Tree Risk Assessment Report: Common and Street Side Trees

David Hawkins, Consulting Arborist
Urban Forestry Solutions, Inc.

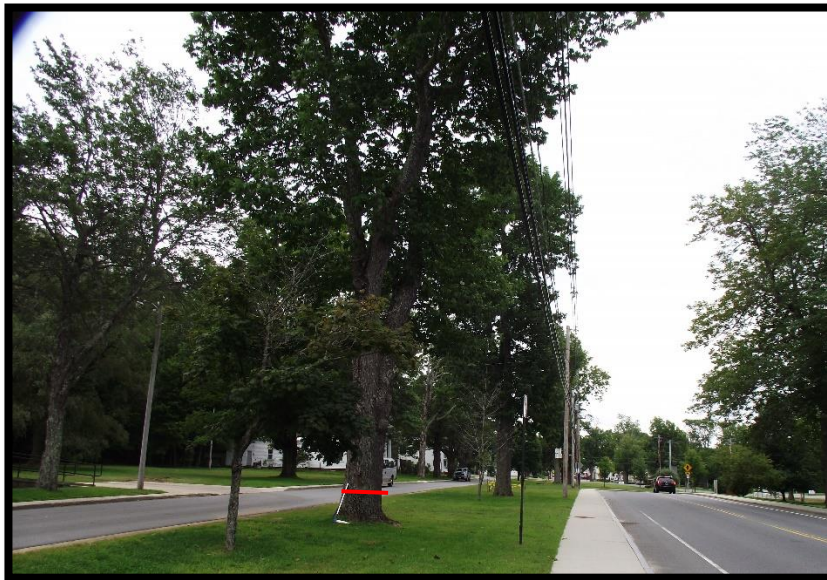
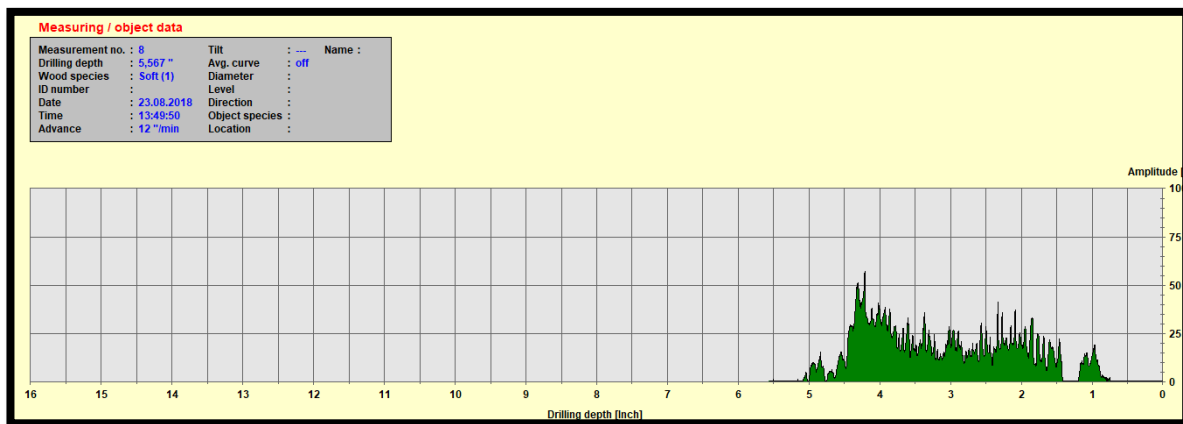
Tree #1: Opposite Library

37-inch DBH³ White Ash (*Fraxinus americana*).

Assessment: Appears healthy with little dieback and good foliage density and color. Major limb over the road and wires has some decay, and a cavity from an old branch break. Sounding the lower trunk with a plastic mallet came back with a hollow sound. 2 probes with a Resistograph confirmed no more than 5 inches of sound wood on the east and west sides of the trunk at 3 feet high (red line in photograph below).

The RS images below show wood resistance as green with high resistance readings up to 4 inches deep. The sharp drop on the graph indicates decayed or absent wood. The numbers below the graph represent inches of probe depth.

- Remove Tree

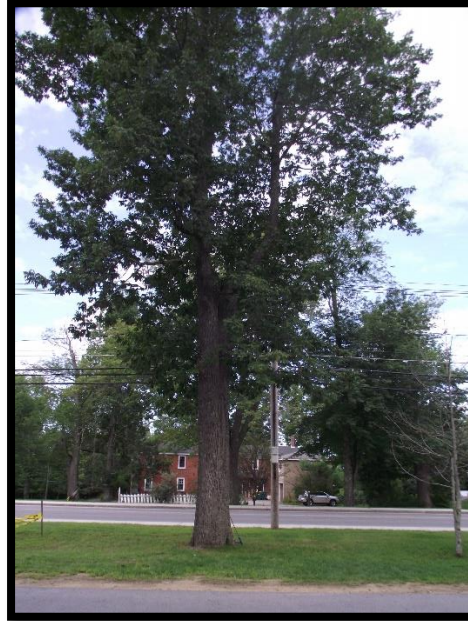
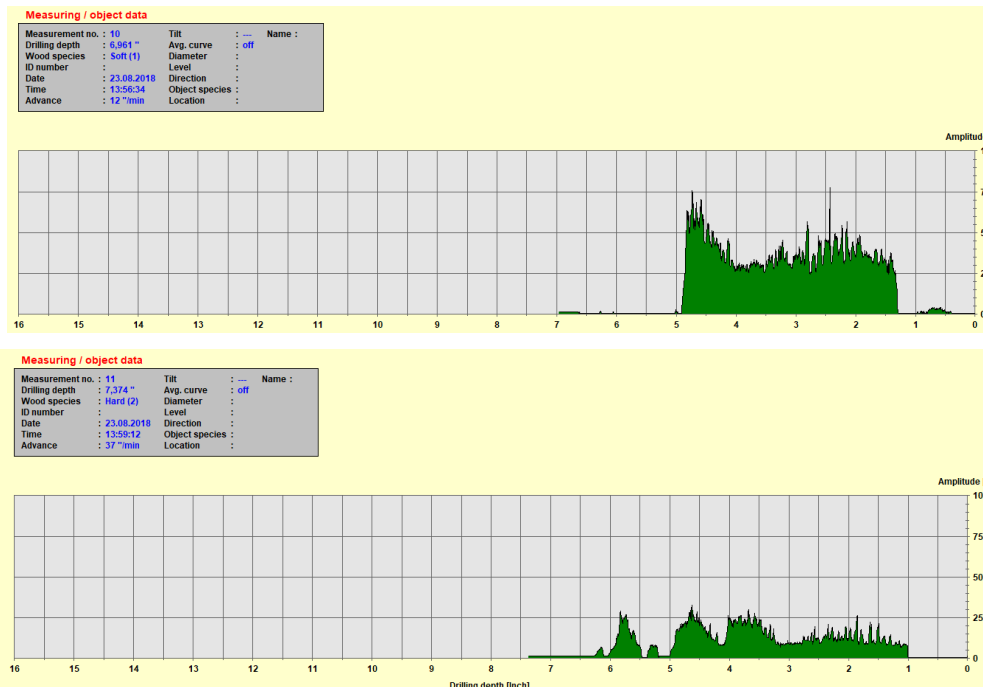
Tree #2: 80 feet south of Tree #1

36-inch DBH White Ash (*Fraxinus americana*).

Assessment: Appears healthy with little dieback and good foliage density and color. Main leader to the north has significant decay and above a small (dead) tree, and the wires for the library street light. Sounding the lower trunk with a plastic mallet came back with a hollow sound.

3 probes with a Resistograph showed low or no resistance at 5 to 6 inches deep (2 probes shown below).

- Remove Tree

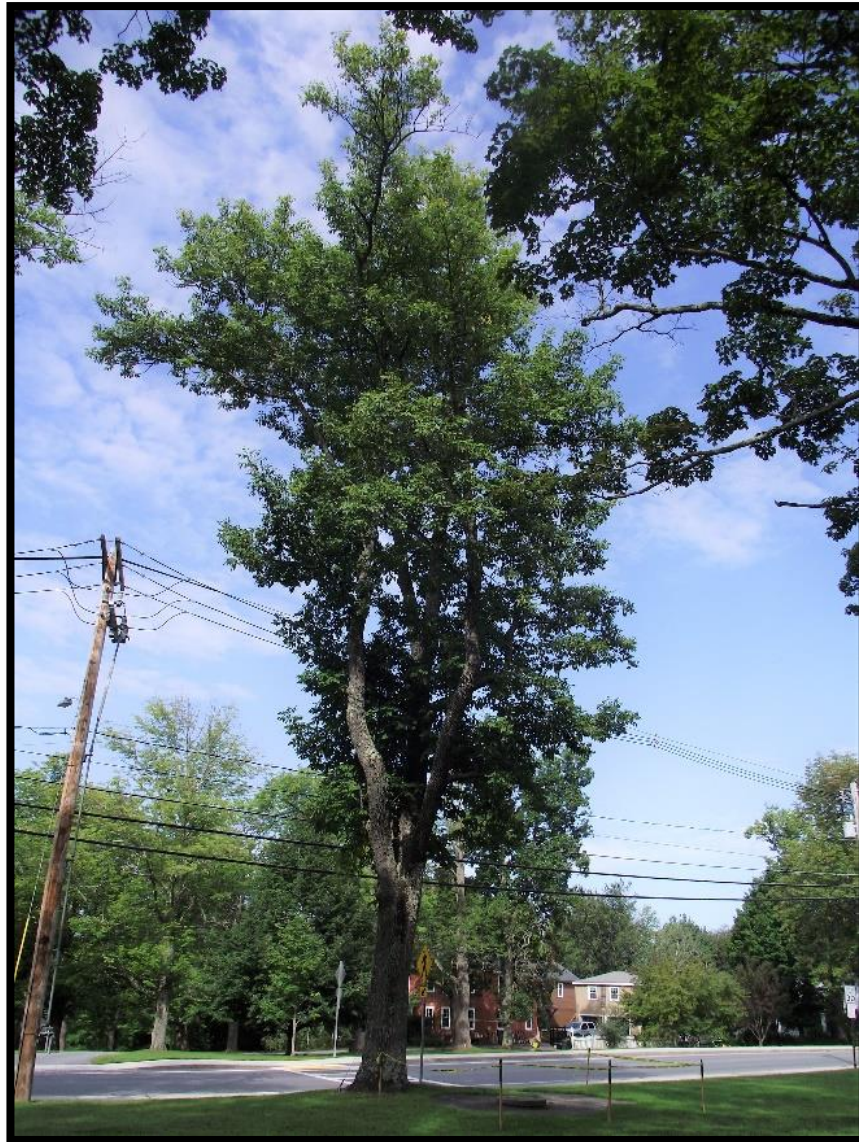
Tree #3: 190 feet south of Tree #2. In front of #17 Boynton

32-inch DBH White Ash (*Fraxinus americana*).

Assessment: Good condition with some small deadwood in the upper crown. No noticeable structural defects

Recommendations:
Prune deadwood if working on nearby trees

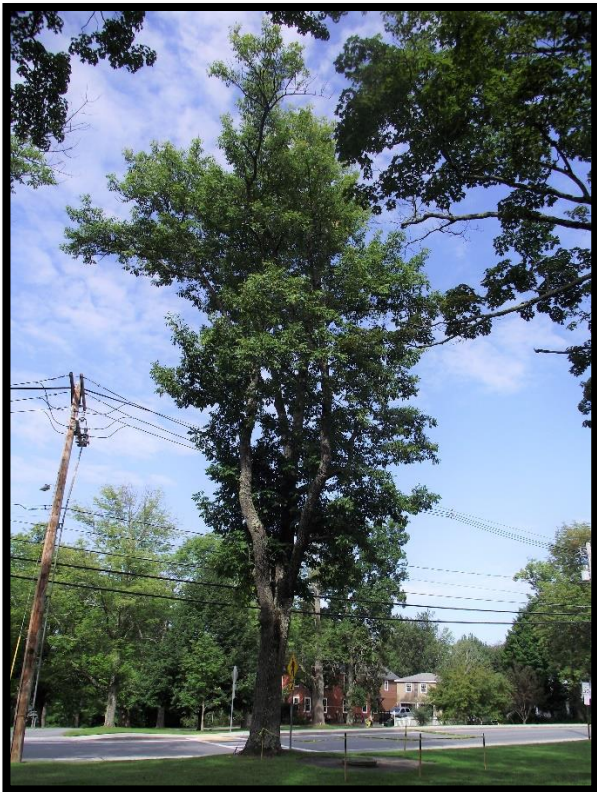
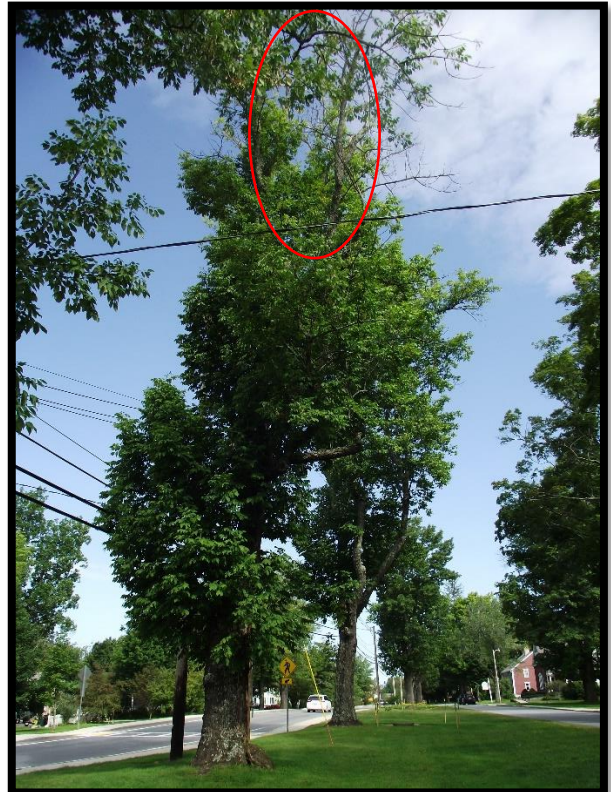
Tree #4: 150 feet south of Tree #3. Next to Verizon Pole #164

31-inch DBH White Ash (*Fraxinus americana*).

Assessment: Fair to good condition. Large burl at base of tree. Large deadwood up to 8 inches diameter. East leader mostly dead with wood pecker damage. Good new growth in lower crown; enough to sustain tree.

Prune deadwood. Remove east leader (circled).

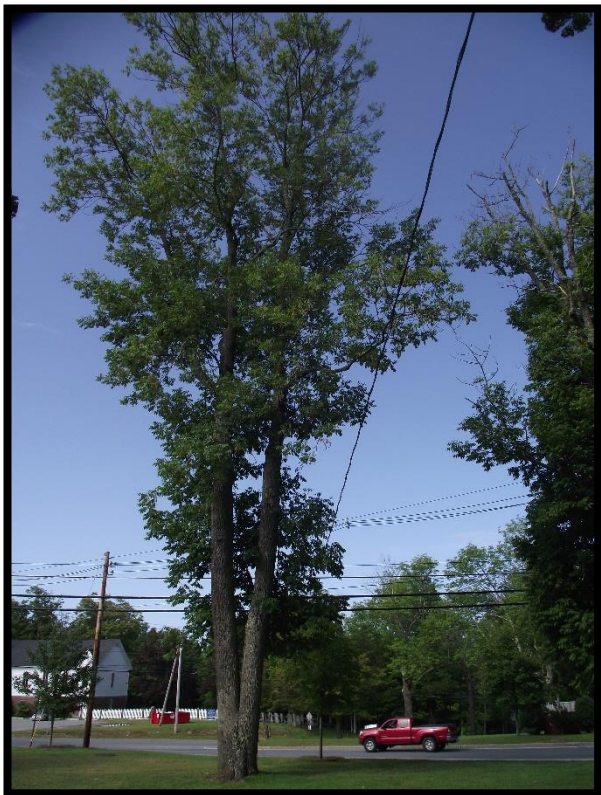
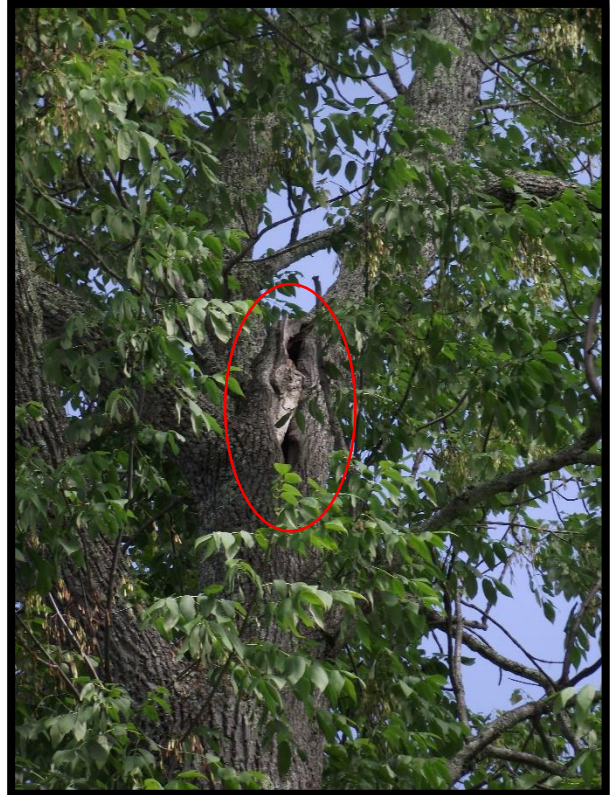
Tree #5: 35 feet south of Tree #4.

42-inch DBH White Ash (*Fraxinus americana*).

Assessment: Fair to good condition. Co-dominant leaders at 5 feet⁴. Pale foliage, heavy seed set with top dieback indicating tree is under stress. Decay on south leader near top. Leader could be compromised

Prune end weight on south lead to reduce stress on decayed area (circled) and co-dom. branch attachment. Install support cable if feasible upon aerial inspection while pruning.

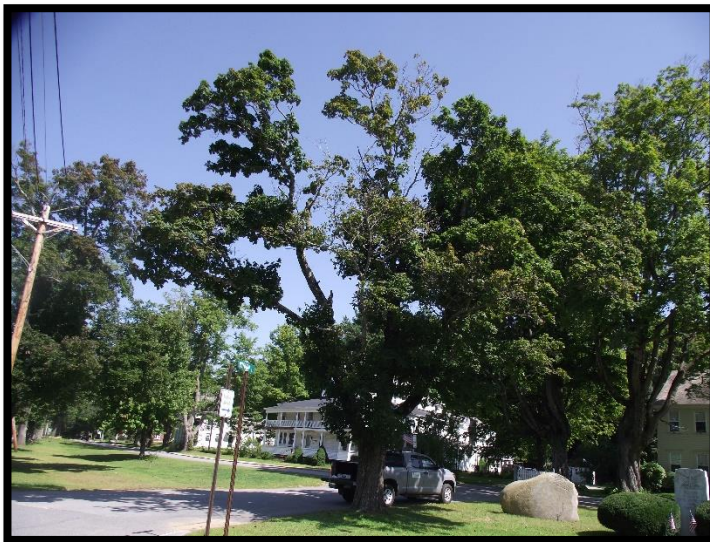
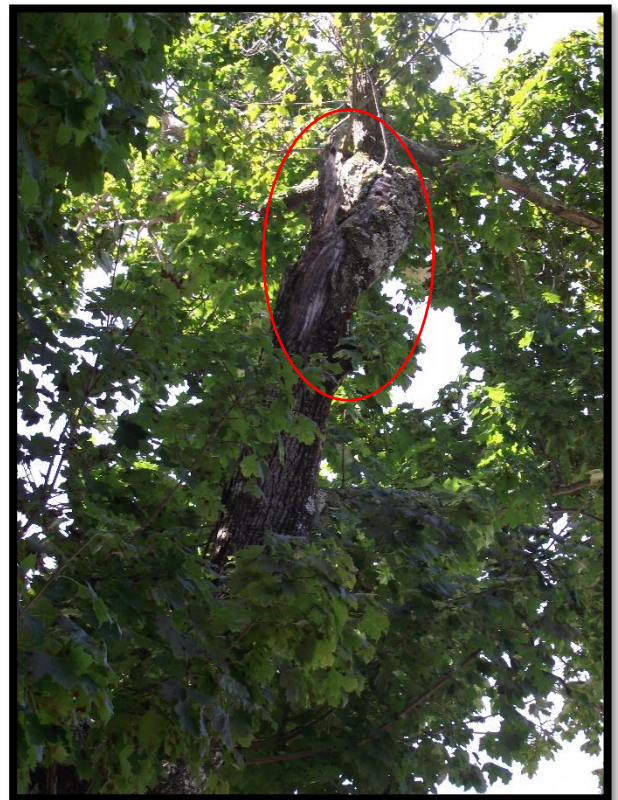
Tree #6: Next to War Memorial.

42-inch DBH Norway Maple (*Acer platanoides*).

Assessment: Fair condition. Crown dieback, large deadwood and decay in main leaders (circled). Poor tree architecture with weak branch attachments.

Remove.

Note: pruning deadwood and reducing crown to lessen chance of failure will leave the tree disfigured.

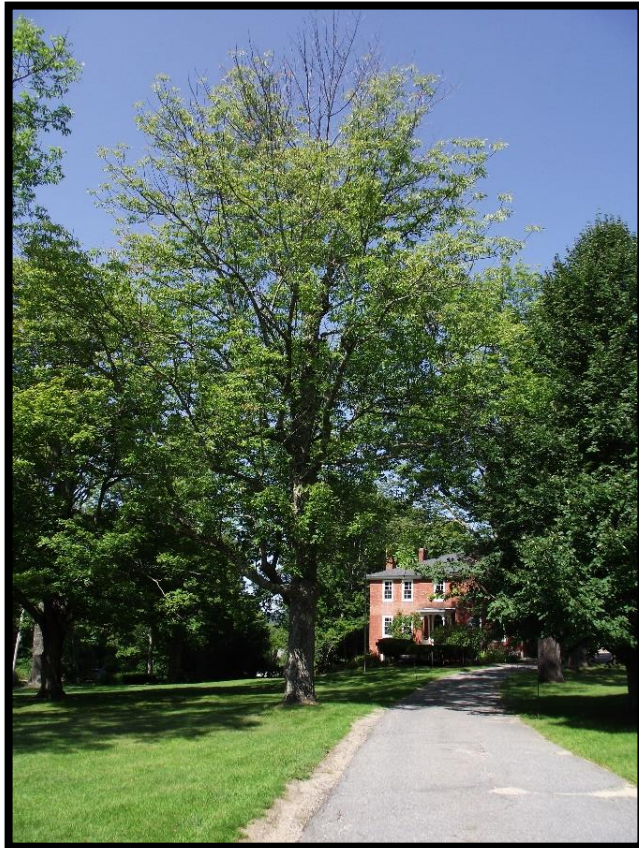
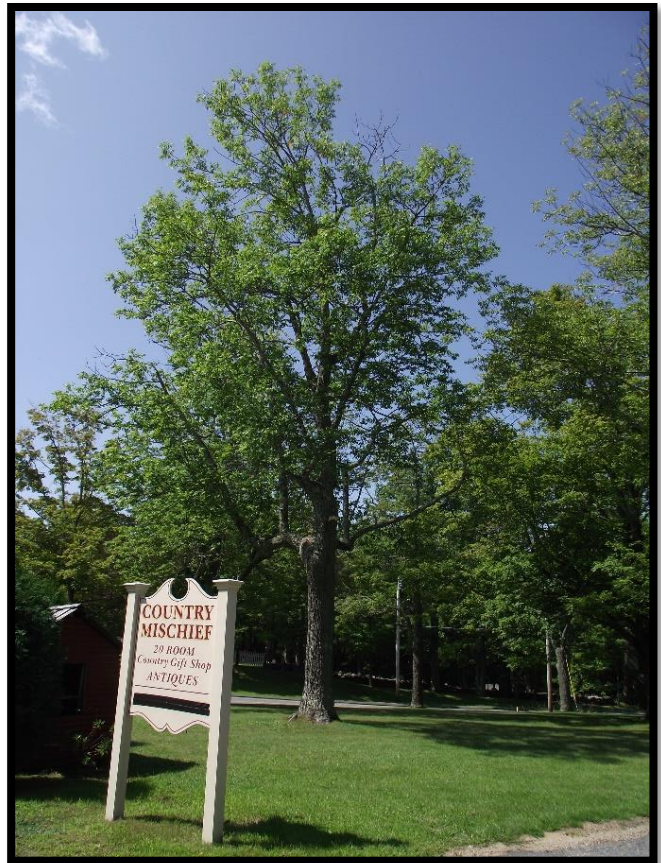
Tree #7: Next to County Mischief driveway – west side.

28-inch DBH White Ash (*Fraxinus americana*).

Assessment: Fair condition. Pale foliage, top dieback and small deadwood throughout crown. Tree is under stress. No major structural defects identified.

Recommendations:
Prune deadwood and monitor health.

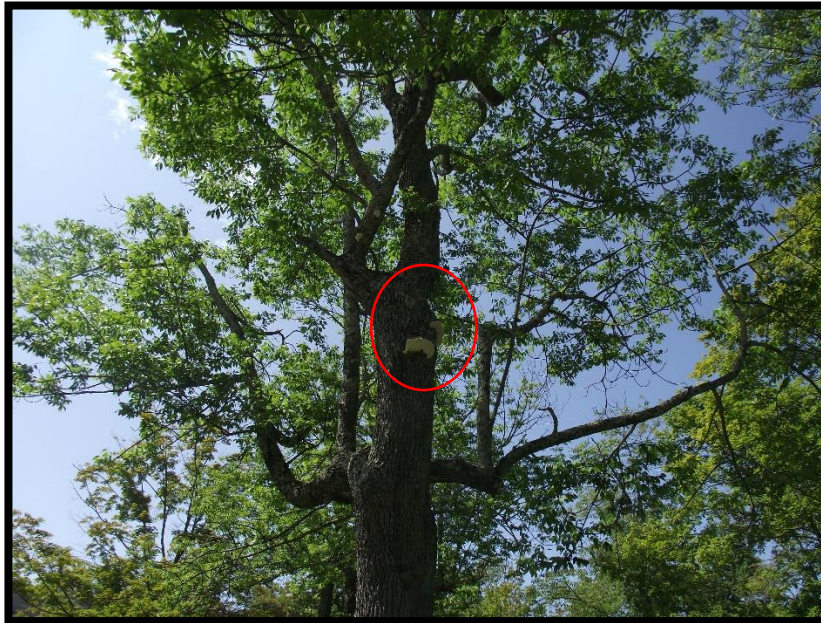
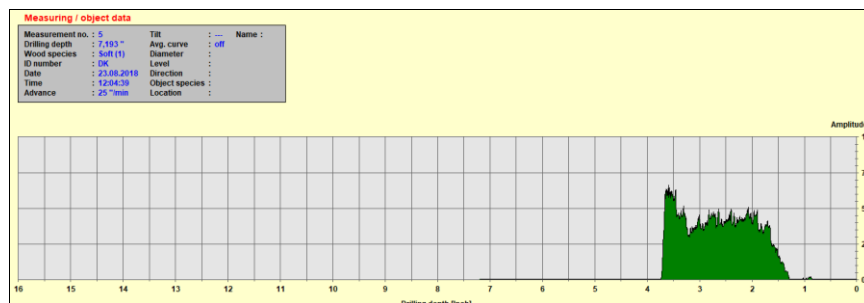
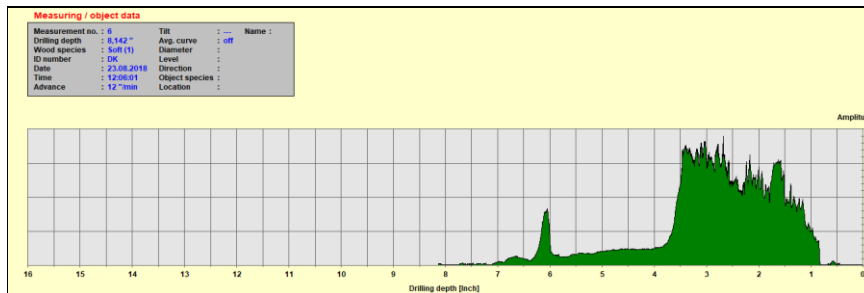
Tree #8: In lawn area 20 west of red outbuilding.
24-inch DBH White Ash (*Fraxinus americana*).

Assessment: Fair condition. Thin crown; top dieback. Decay fungus present on east side of main lead (circled). Sounding lower trunk indicated internal decay. Presence of fungus and 'hollow' sound may indicate significant decay in the lower trunk and crown.
RS reading indicate 3 to 4 inches of solid wood in probes sites at 3 – 4 feet high on trunk.

Recommendations:
Remove

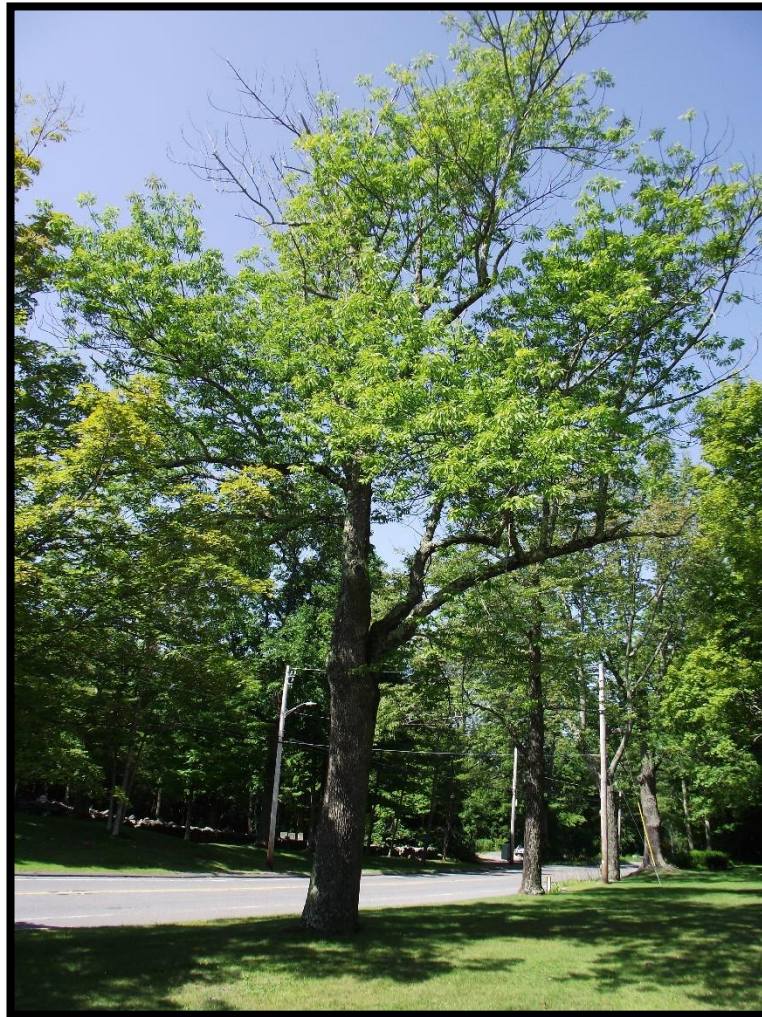
Tree #9: 50 southwest of Tree #8. Southern-most tree in row of trees next to Patriot Road.

31-inch DBH White Ash (*Fraxinus americana*).

Assessment: Fair to good condition. Crown somewhat thin but has good foliage color. Some deadwood 8 inches diameter and less.

Recommendations:
Prune deadwood and monitor health.

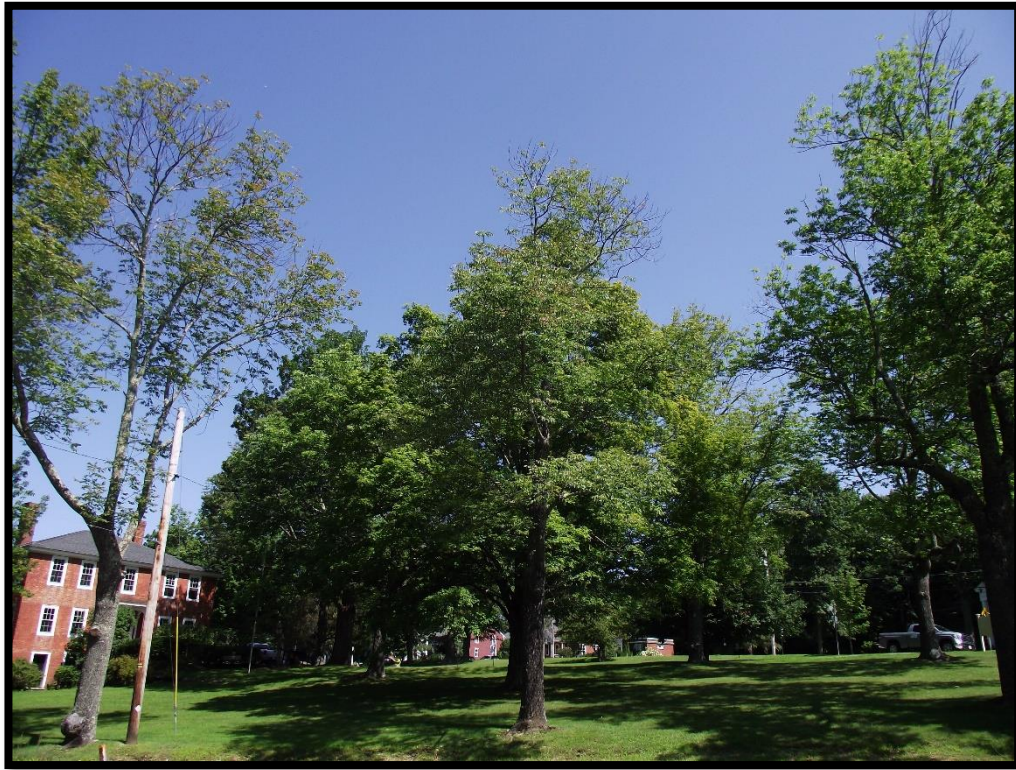
Tree #10: 35 north of Tree #9.

21-inch DBH White Ash (*Fraxinus americana*).

Assessment: Fair condition. Crown thin with pale foliage. Some deadwood 3 inches diameter and less. Tree appears stress

Recommendations:
Prune deadwood and monitor health.

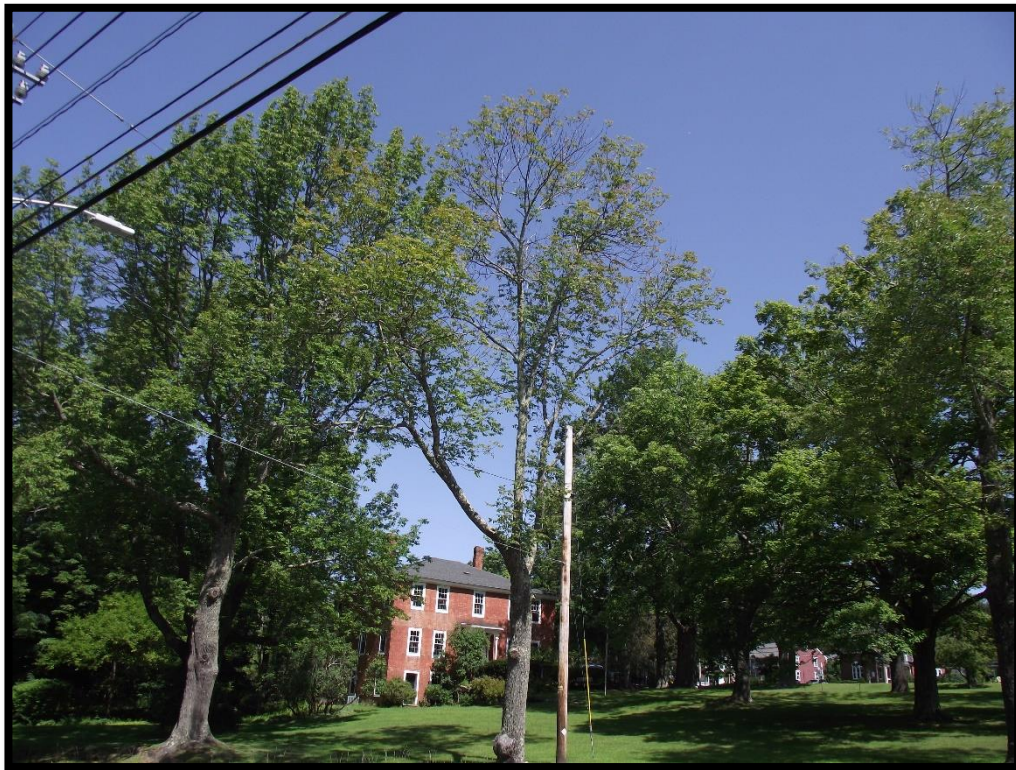
Tree #11: Next to Pole #104.5.

24-inch DBH White Ash (*Fraxinus americana*).

Assessment: Fair condition. Crown thin with pale foliage. Early fall color indicating tree is under stress. Some deadwood 3 inches diameter and less over lawn and road.

Recommendations:
Prune deadwood and monitor health.

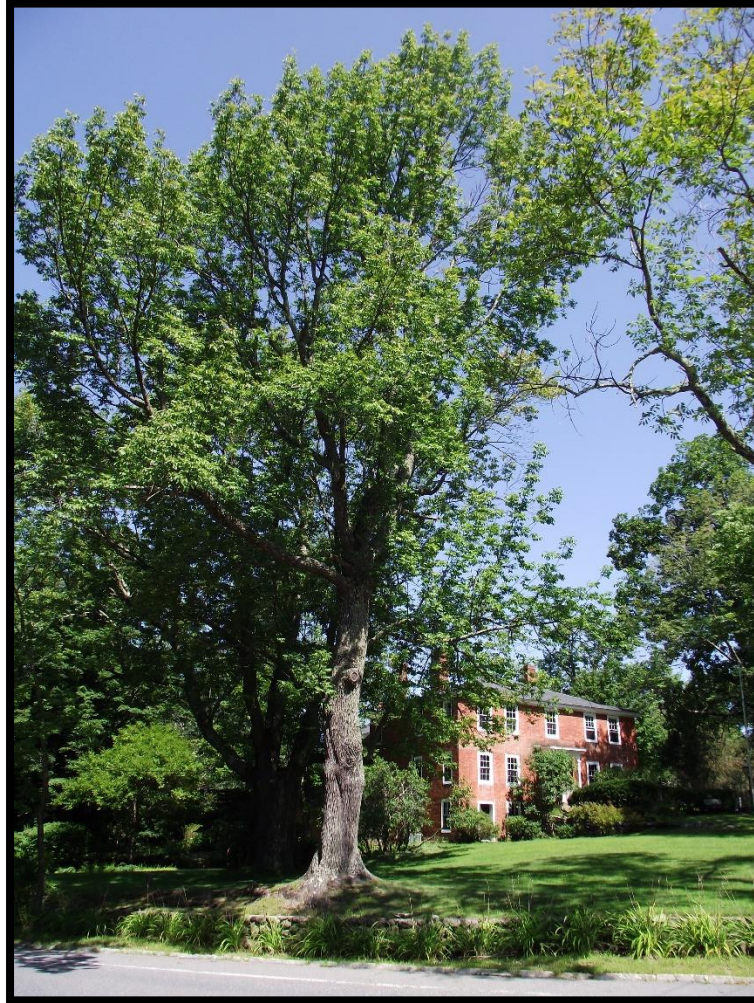
Tree #12: Northern-most tree in row and next to Country Mischief property line

35-inch DBH White Ash (*Fraxinus americana*).

Assessment: Good to condition. Some deadwood less than 4 inches. No major structural defects identified.

Prune any deadwood over road

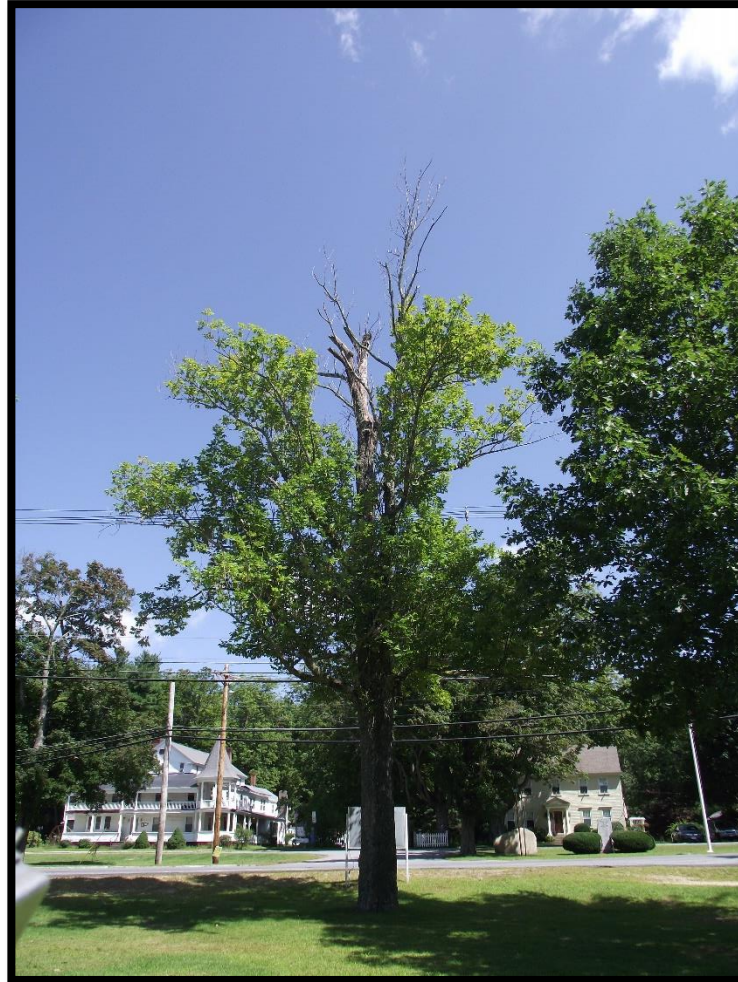
Tree #13: Northeast portion of common. Next to notice board on Petersham Road

31-inch DBH White Ash (*Fraxinus americana*).

Assessment: Poor to fair condition. Central leader and only remaining leader dead or dying. Deadwood 15 inches diameter and less. Remaining lower foliage is vigorous and may be enough to sustain the tree.

Prune and monitor or consider removal. Pruning will result in an unbalance, disfigured tree.

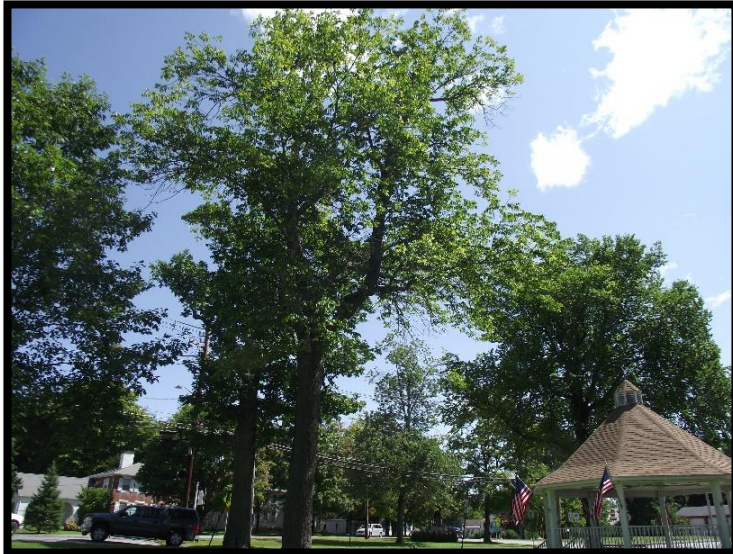
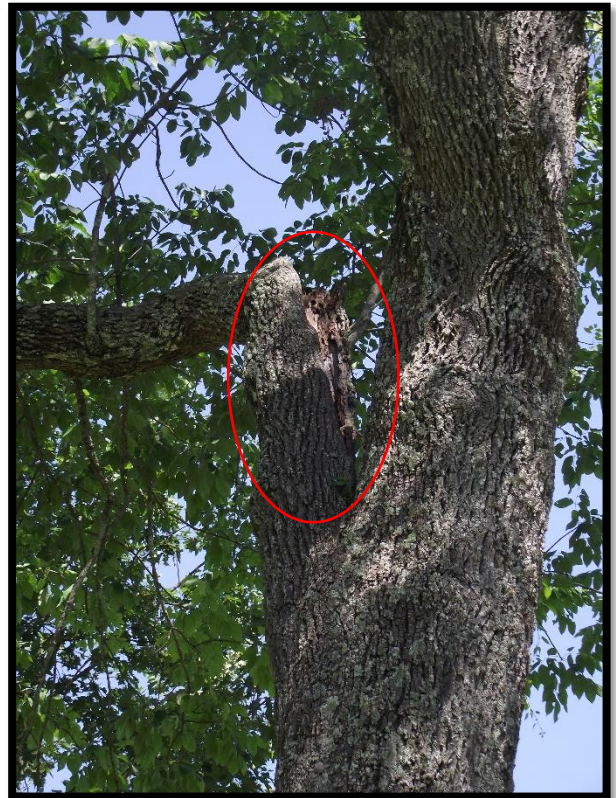
Tree #14: 50 feet south of Tree #13 and 30 feet north of Gazebo

34-inch DBH White Ash (*Fraxinus americana*).

Assessment: Fair to good condition. Foliage good color with a little crown thinning. Deadwood throughout crown. Lead over gazebo heavy. North lower leader decayed near base. Periodic high use area.

Prune all deadwood. Prune to reduce end weight from leader over gazebo and decayed north leader.

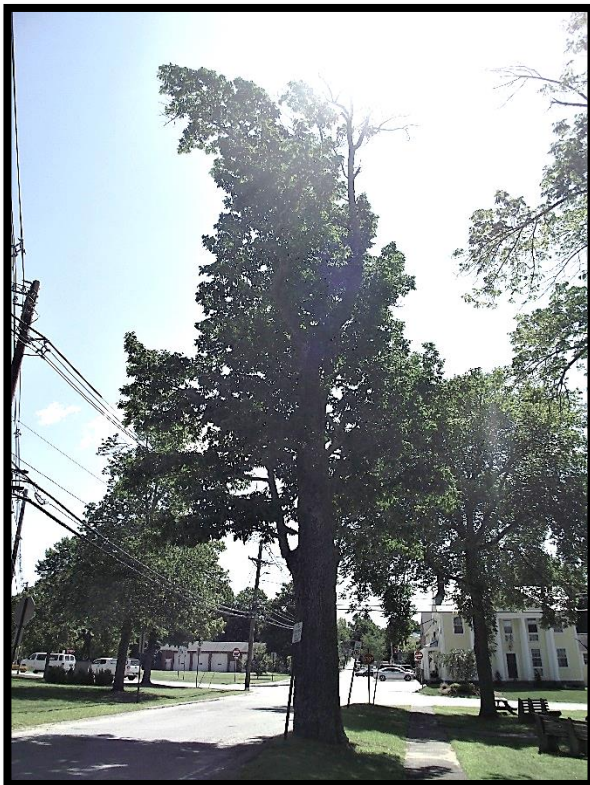
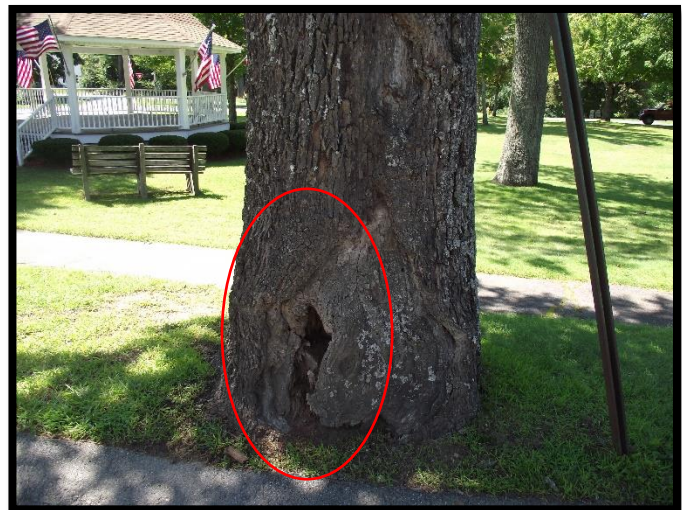
Tree #15: 30 feet east of Tree #14 between road and sidewalk. Next to 'No Parking' sign.

41-inch DBH White Ash (*Fraxinus americana*).

Assessment: Fair to good condition. Good foliage color. Large deadwood in upper crown over sidewalk. Open cavities on west side of trunk possibly from old pruning cuts or wounds. Large decayed area on lower trunk east (road) side. Trunk sounding did not reveal significant decay in lower trunk, but it's possible the mid and upper trunk may be hollow or decayed. Considering it's location next to the road and wires, and the amount and severity of the defects identified, retaining this tree is risky.

Remove

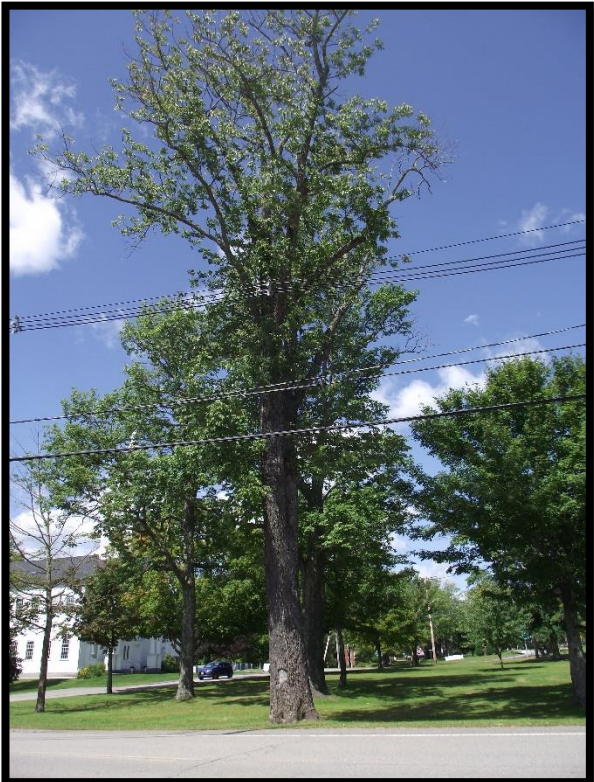
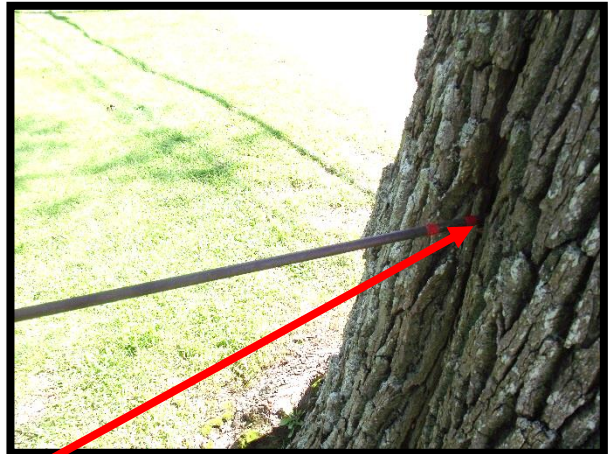
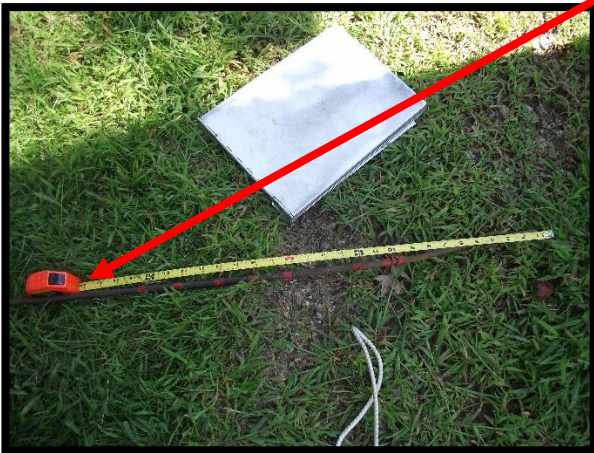
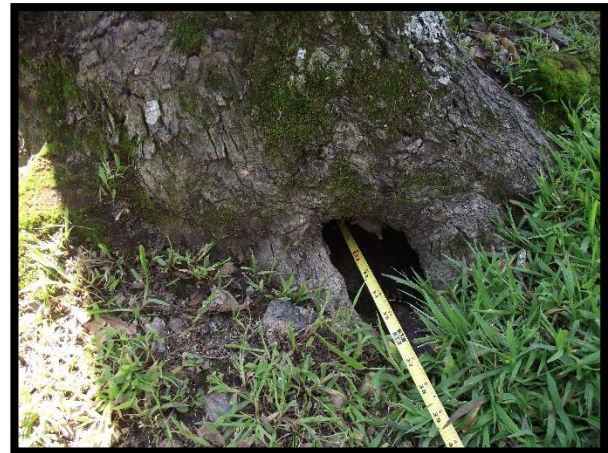
Tree #16: South edge of common next to Dudley Road

34-inch DBH White Ash (*Fraxinus americana*).

Assessment: Poor condition. Large deadwood, crown dieback present. Crown weight and lean towards road and wires. Significant trunk decay, open crack and cavities identified. Metal probe rod inserted to 20 inches as 4 feet on trunk and tape measure to 30 inches in basal cavity. No RS needed.

Recommendations:
Remove ASAP

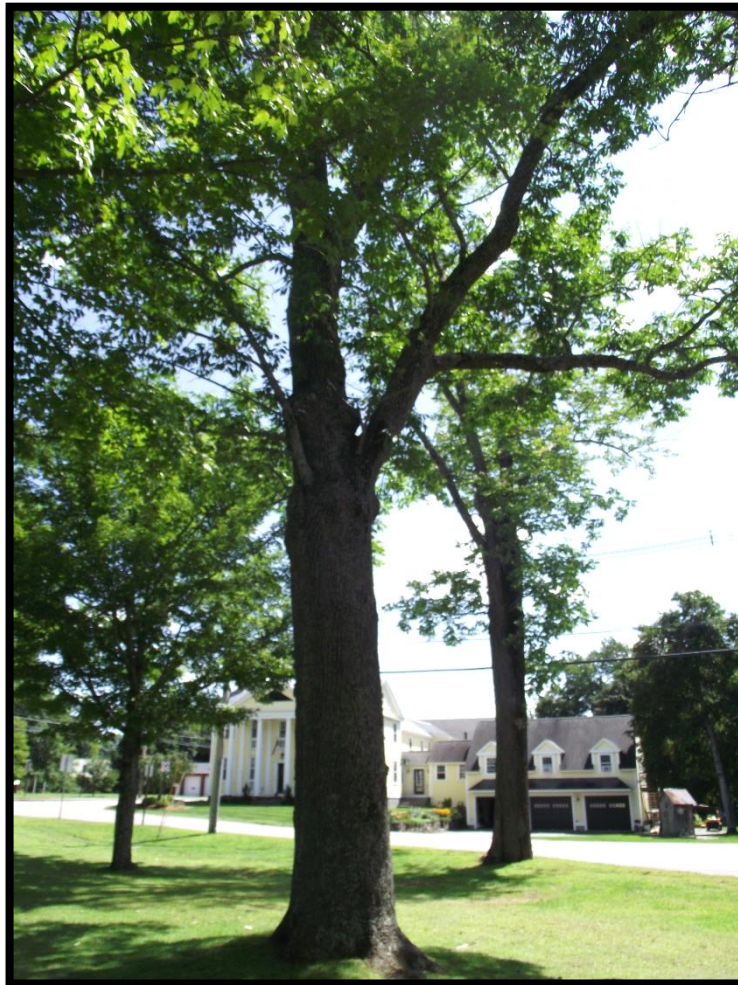
Tree #17: 50 Northwest of Tree #16.

40-inch DBH White Ash (*Fraxinus americana*).

Assessment: Good condition. Some thinning and dieback. Deadwood less than 5 inches. Periodically a high use area

Recommendations:
Prune deadwood

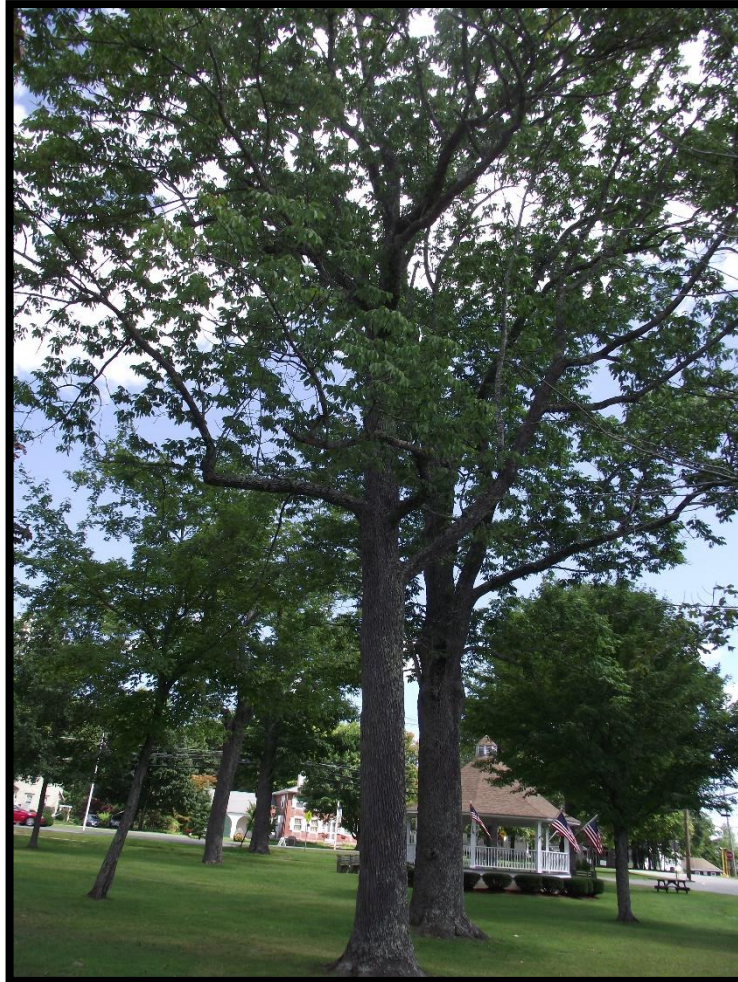
Tree #18: 20 feet west of Tree #17.

26-inch DBH White Ash (*Fraxinus americana*).

Assessment: Good condition. Some thinning and dieback. Deadwood less than 3 inches. Periodically a high use area

Recommendations:
Prune deadwood

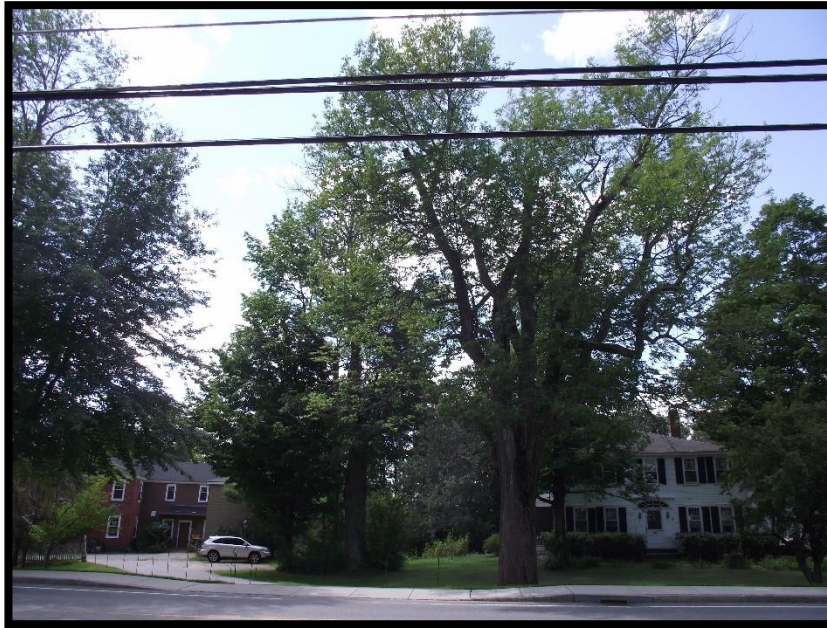
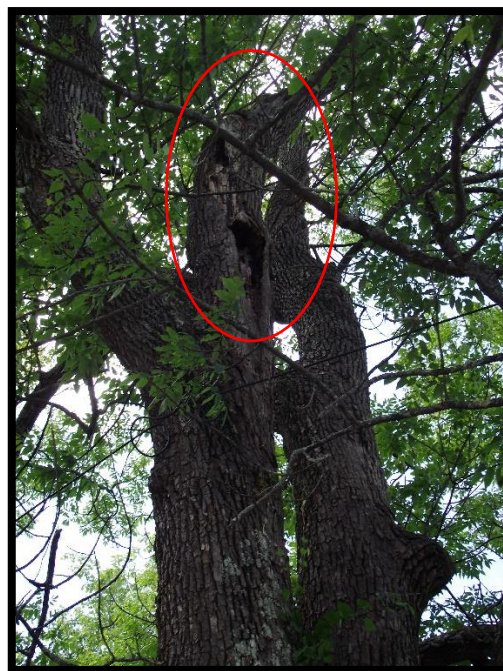
Tree #19: North side of the north driveway for Country Mischief off Baldwinville Rd.

45-inch DBH White Ash (*Fraxinus americana*).

Assessment: Good condition. Some thinning, dieback and deadwood at the top. Large dead stub in lower middle of tree (circled)

Prune deadwood and dead stub
