Town of Templeton, MA

Weatherization Work for Town Hall, Boynton Public Library, Baldwinville Fire Station, and Cemetery Garage

INVITATION TO BID

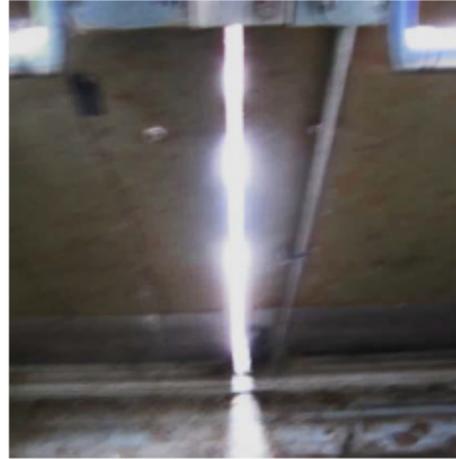
Right: Town Hall – photo shows considerable (1.5") gap between the exterior double-doors. Note the daylight peering through! The failing/missing weatherstrip allows air, moisture (humidity, rain, etc.), outdoor pollutants, and insects to infiltrate the building envelope. Installing new weatherstrip on the exterior doors will improve energy performance, occupant comfort, and IAQ.

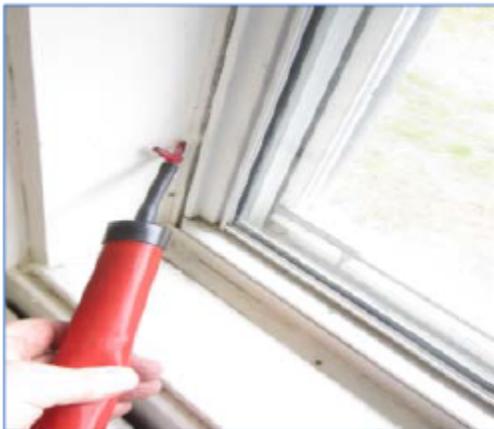
Left: Town Hall – testing of the windows indicates considerable air leakage at sashes. The metal-frame units need new weatherstrip installed. The older wood-framed units are not used, and therefore should be sealed shut, tightening these units, alleviating drafts, and improving occupant comfort and the building's overall energy performance.

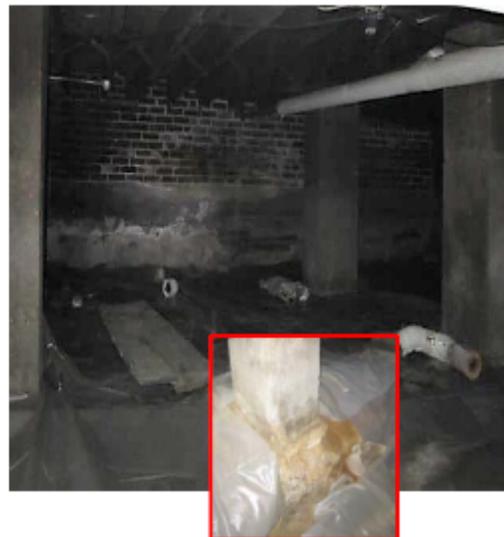
Sealed Basement

Right: Town Hall – The unconditioned basement beneath the Selectman and Town Administrators office areas has a dirt floor, a failing vapor barrier, and significant air and moisture leakage between the basement and conditioned spaces above. A continuous, sealed vapor barrier and effective air and thermal barriers need to be installed, covering the dirt floor, the foundation walls, and the band joist.

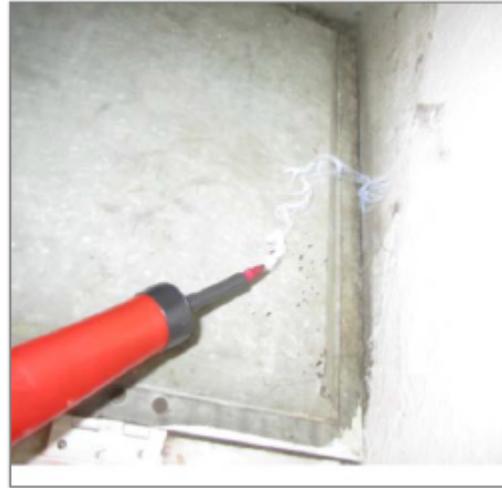
Cupola Chases

Right: Town Hall – Originally an elementary school, the building has large 2' W x 3' D Cupola chases (e.g. chimneys) in multiple sections of building walls. The dampers on these old chases tested very leaky. They allow communication between the conditioned spaces and the attic/ outdoors (i.e. air and moisture infiltration). These chase dampers need to be effectively air-sealed with rigid board insulation and appropriate sealants.

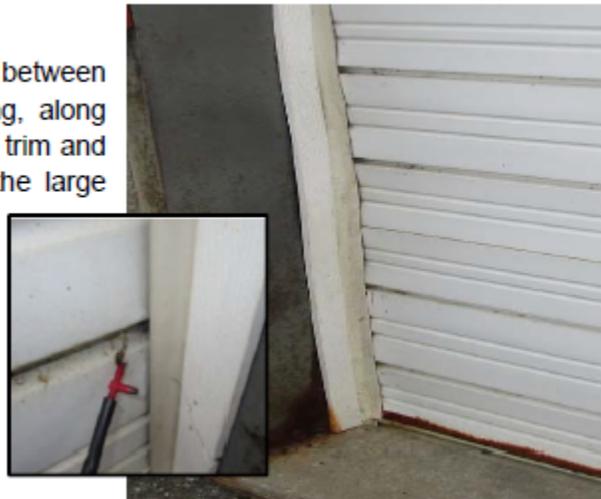
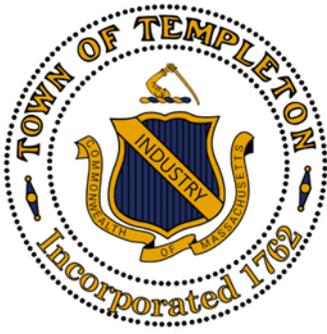
Right: Fire Sta. #2 – photo shows large gaps between the overhead door and its weatherstripping, along with deteriorated and rusted sections of the trim and framing. The insert shows a close-up of the large gaps. The overhead doors are very leaky and need new, effective weatherstripping materials to be installed.
