Stoney Bridge Road Culvert Replacement Alternatives Analysis

Stoney Bridge Road
Templeton, Massachusetts
June 5, 2019

Prepared for:
Town of Templeton
160 Patriots Road
East Templeton, Massachusetts 01438

Prepared by:
MILONE & MACBROOM, INC.
One Financial Plaza
1350 Main Street, Suite 1012
Springfield, Massachusetts 01103
(413) 241-6920
www.mminc.com

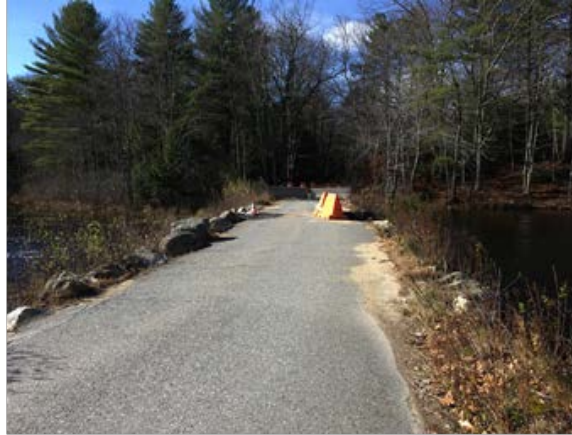
Figure 1: Looking west down Stoney Bridge Road over the existing culvert crossing

The existing culvert is located on Stoney Bridge Road at Stone Bridge Pond, a location also known as Stone Bridge. The existing structure is an approximately 17-foot-long stone culvert that is approximately 2 feet high by 6 feet wide. Cut stone masonry form the walls of the culvert, and a granite slab over the culvert supports the roadway above. The culvert has a natural channel bottom and a short reach along the culvert that connects the upper and lower impoundment. A plume of sediment was observed at the inlet, and a scour hole exists at the culvert outlet, which is indicative of a constricted inlet and high-flow velocity through the culvert.

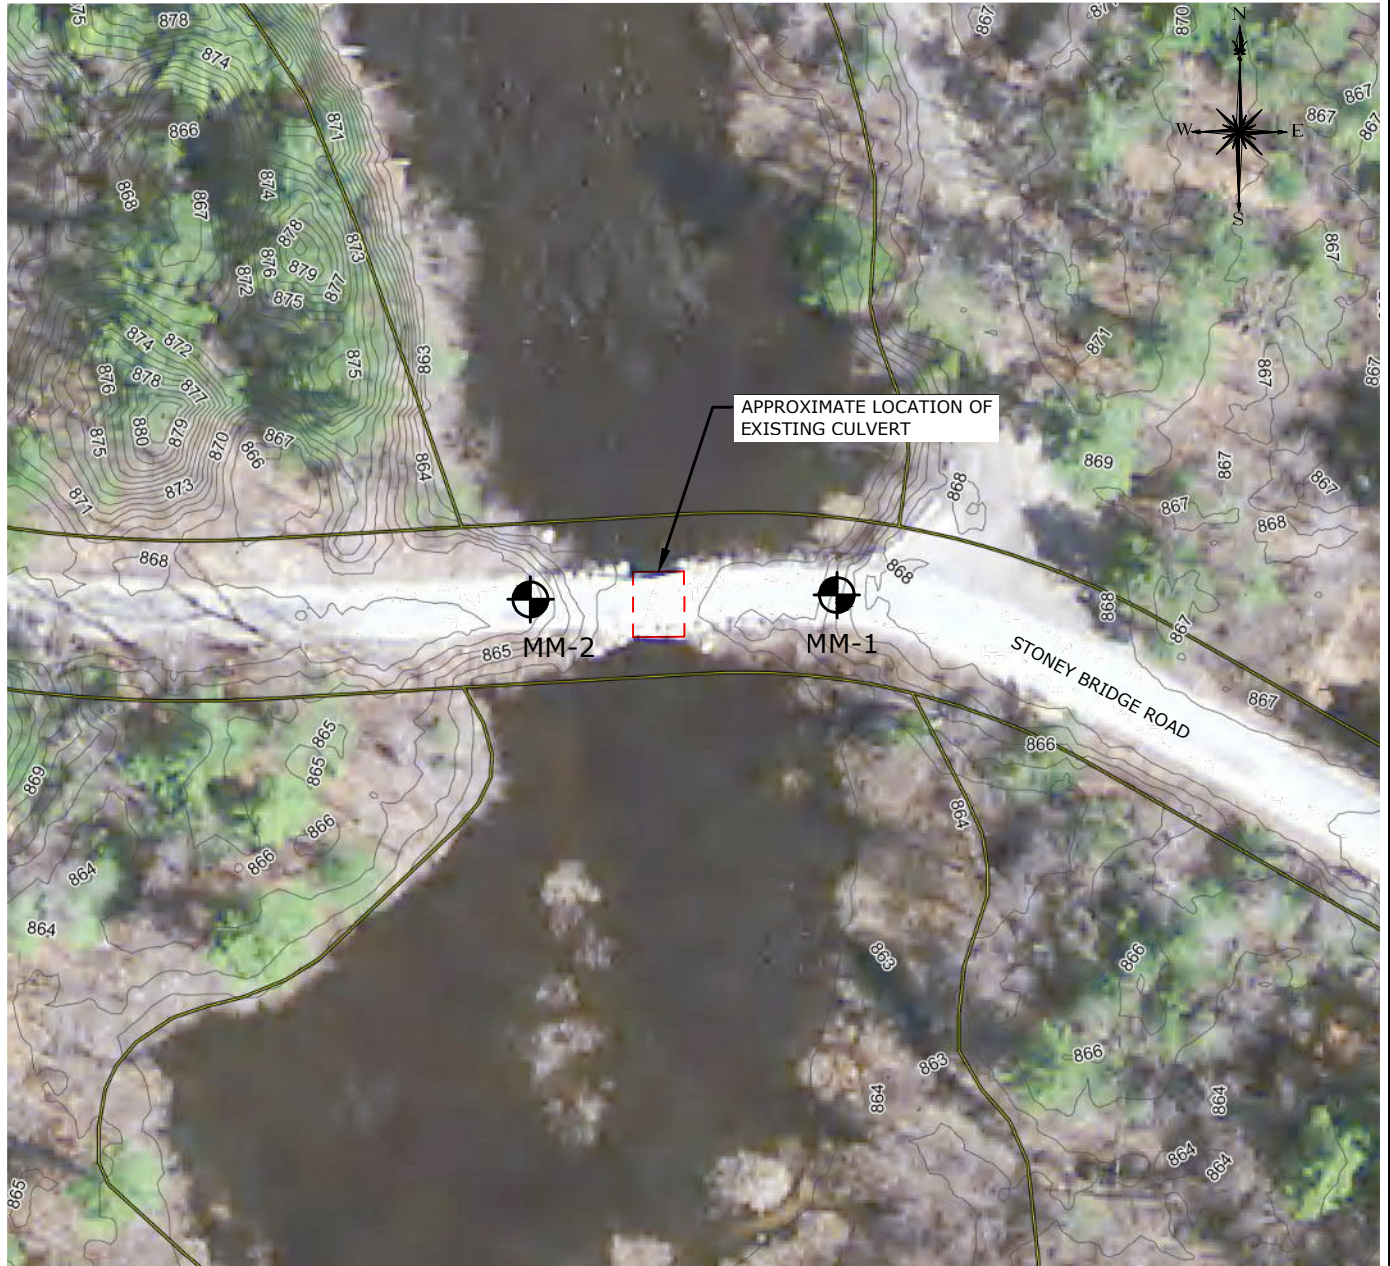
MMI observed two borings (MM-1 and MM-2) that were performed by Seaboard Drilling, Inc. of Chicopee, Massachusetts, on December 26, 2018. The borings were performed to explore the subsurface conditions near the proposed culvert replacement. The borings were located by taping/pacing from existing site features, and approximate boring locations are shown on Figure 2 – Subsurface Exploration Location Plan contained in Appendix 1.

Natural deposits consisting of variable amounts of silt, sand, and gravel were encountered below the fill and are generally described as loose to medium dense in Boring MM-1 and dense to very dense in Boring MM-2. Boring MM-1 consisted predominately of gray-brown fine to medium sand, little to some silt with select split-spoon samples consisting of predominately silt, some to and fine to medium sand. Boring MM-2 consisted predominately of light brown to brown fine to coarse sand, little to and fine to coarse gravel, trace to and silt.

Groundwater was encountered in both borings (MM-1 and MM-2) at a depth of approximately 4.0 feet below existing grades. Groundwater levels will vary depending on factors such as temperature, season, precipitation, construction activity, and other conditions, which may be different from those at the time of these observations.
