August 29, 2018

RE: Tree Risk Assessment Report: Common and Street Side Trees

David Hawkins, Consulting Arborist
Urban Forestry Solutions, Inc.

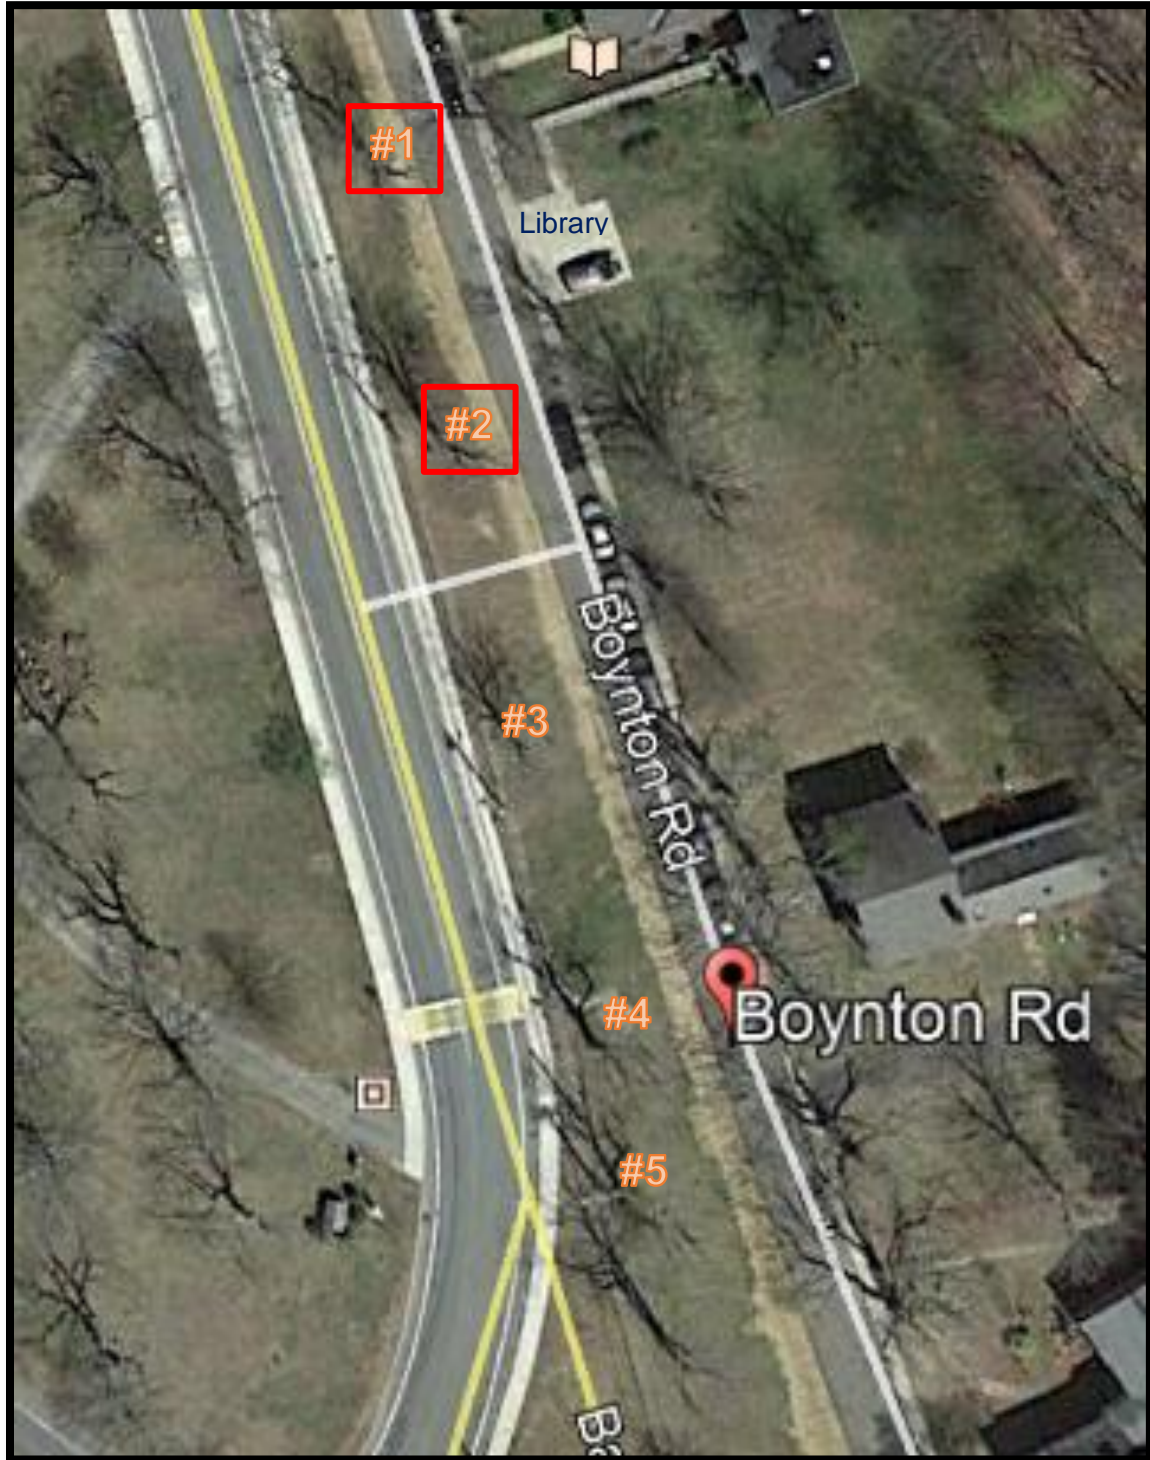
Area 1: Baldwinville/Boynton Lawn Area

The remainder of the report is divided by sections with a site illustration and an assessment, recommendations and photographs of each tree. Trees on the site illustration highlighted with a red box are recommended removals.
